REPORT
DEPRECIATION SERVICES

Chelsea Gardens - Strata Plan LMS 1416
13860 – 13888 70th Avenue, Surrey, BC

Date: March 4, 2026
Project Number: VR24565

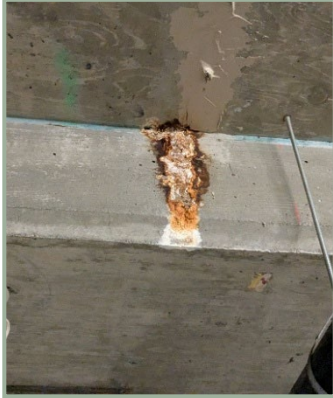
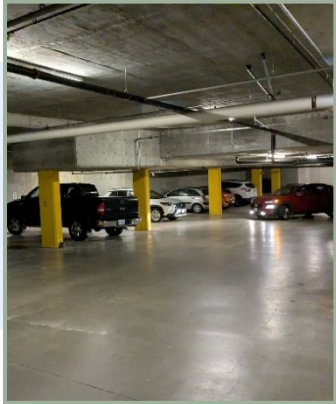
Year Installed:	1995	
	Typical Service Life (years):	50	
	Effective Age (years):	30	
	Remaining Service Life (years):	20	
	Planned Renewal Date:	2045	
<p>Description: This item includes the two underground parkades' concrete walls, ceiling and floor slab surfaces. This includes the parkade underneath Mayfair and Kensington, and the other parkade underneath Windsor.</p> <p>Condition: It was noted that targeted repairs have been performed in the parkade for the last three years. The general condition of the concrete is average. Signs of water ingress were observed via efflorescence and corrosion staining on the surfaces of the concrete in the parkade below Mayfair.</p> <p>Short-Term Action Required: It is recommended to perform a parkade condition review to more accurately determine the source of the water ingress problem in the parkade area below Mayfair.</p> <p>Comments: The structural capacity of the slabs and walls is expected to last for the life of the building. The 50-year typical service life refers to a rough estimate as to when the owners may expect the need for concrete repairs to address issues such as delamination, water intrusion, and wear. The reserve costs for the parkade include performing targeted repairs on the concrete surfaces noted in the description. An allowance has been allotted in 2026 for a parkade condition review and potential repair work that may follow. Additional allowance has been allotted three years prior to the renewal year for condition review and targeted repair work.</p>

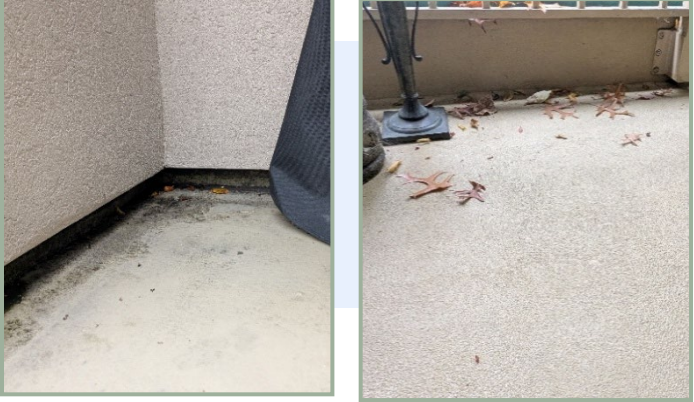
3	BALCONY MEMBRANE ASSEMBLIES (CONDOS)			
BUILDING ENVELOPE AND STRUCTURE	Location:	Condo building balcony surfaces

Year Installed:	2007		
	Typical Service Life (years):	25		
	Effective Age (years):	20		
	Remaining Service Life (years):	5		
	Planned Renewal Date:	2030		
	<p>Description: This item includes the liquid-applied balcony membrane on all the balconies of the condo buildings.</p> <p>Condition: It was noted that these membranes were fully replaced during the building envelope remediation project around 2007. The balcony membranes were observed to be in poor to fair condition. Generally, those that were covered appeared to be in much better condition (Photo on the right) compared to the balconies that were exposed (Photo on the left). The strata president reported that targeted repairs have been performed on the balcony membranes over the last five years.</p> <p>Short-Term Action Required: The balcony membranes that were observed to be in poor condition had cracking at the joints between the wall and the balcony floor surface. These cracks can allow water to penetrate the balcony assembly and potentially facilitate water ingress into the nearby wall assemblies. JRS recommends conducting a condition assessment and replacing any balcony membranes that are in poor condition.</p> <p>Comments: The reserve costs for this asset include replacing all the balcony membranes on the balconies. This item should be included in the BECA mentioned in item #6 to more accurately determine its condition and scope of repair work. A percentage of the reserve cost has been allotted in 2027 for targeted replacements of the balcony membranes in poor condition.</p>

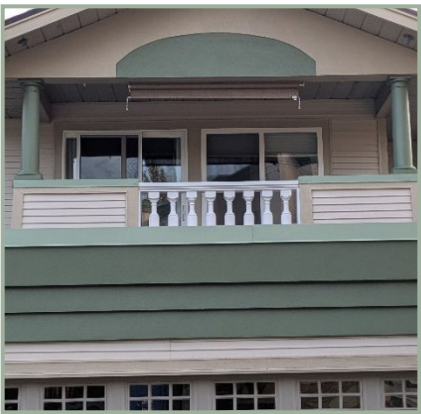
Year Installed:	2017	
	Typical Service Life (years):	30	
	Effective Age (years):	8	
	Remaining Service Life (years):	22	
	Planned Renewal Date:	2047	
	<p>Description: This item includes the wood spindle guardrails on the decks of the townhouses. It was observed that some of these have been guarded with a transparent plastic panel or completely replaced with aluminum guardrails.</p> <p>Condition: It was noted that these rails have been getting replaced from 2017 to 2021. The spindle guardrail assembly is in fair condition.</p> <p>Comments: The reserve costs include replacing the spindle guard assemblies to aluminum guardrails.</p>

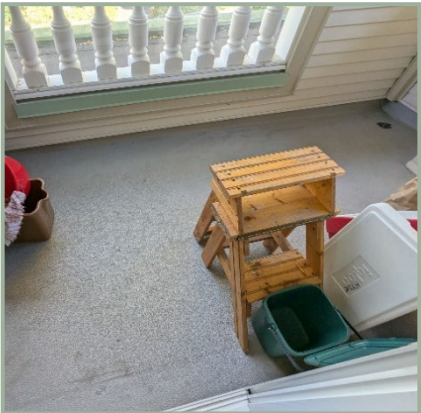
Year Installed:	1995	
	Typical Service Life (years):	30	
	Effective Age (years):	25	
	Remaining Service Life (years):	5	
	Planned Renewal Date:	2030	
	<p>Description: This item includes the PVC waterproofing sheet membrane on all the decks of the townhouses.</p> <p>Condition: The deck membrane is in reasonable condition with no reports or observations of deficiencies. It should be noted that we did not get a chance to review many of the townhouse unit decks. Additionally, it was noted that some decks have been selectively repaired/replaced in 2009, 2019 and 2021.</p> <p>Comments: The reserve costs include fully replacing the deck membranes on the townhouses. This item should be included in the BECA mentioned in item #6 to more accurately determine its remaining service life.</p>

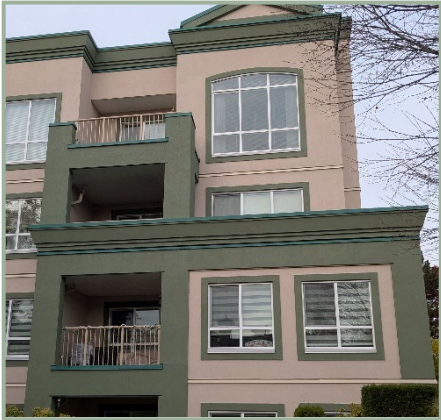
BUILDING ENVELOPE AND STRUCTURE	Location:		Building exterior of condos/clubhouse building
	Year Installed:		1995
	Typical Service Life (years):		30
	Effective Age (years):		25
	Remaining Service Life (years):		5
	Planned Renewal Date:		2030
	<p>Description: This item includes the stucco cladding on the Mayfair, Kensington and Windsor condo buildings and the Clubhouse building.</p> <p>Condition: The stucco walls are in reasonable condition with no reports or observations of water ingress. It was noted that the exterior walls around the windows were replaced with a rainscreen system during the envelope remediation project in 2007.</p> <p>Comments: We recommend performing a Building Envelope Condition Assessment (BECA) in 2026 to better understand the condition of the building envelope system and more accurately determine their remaining service life and the scope of repair/renewal work needed. In the assessment, it is recommended to determine the remaining parts of the stucco cladding from the original construction and replace these with the rain-screen system. The reserve costs include replacing all the stucco cladding on the condo buildings and the Clubhouse building. An allowance has been made for the BECA mentioned above.</p>

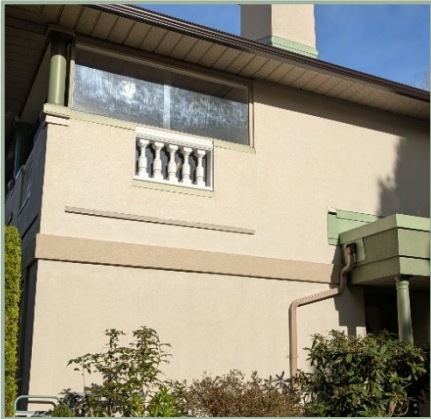
BUILDING ENVELOPE AND STRUCTURE	Location:		Building exterior of townhouses
	Year Installed:		1995
	Typical Service Life (years):		30
	Effective Age (years):		20
	Remaining Service Life (years):		10
	Planned Renewal Date:		2035
<p>Description: This item includes the stucco cladding on all the townhouses throughout the property.</p> <p>Condition: The stucco walls are in reasonable condition. No signs of water ingress or problems were observed or reported. It was informed that annual building envelope repairs have been performed on the townhouses as an ongoing maintenance item.</p> <p>Comments: The reserve costs include full renewal of the stucco cladding on the townhouses. The stucco walls for the townhouses should be included in the BECA mentioned in item #6 to more accurately determine its remaining service life.</p>

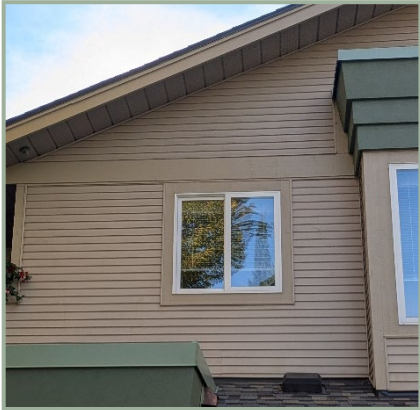
BUILDING ENVELOPE AND STRUCTURE	Location:		Building exterior of townhouses
	Year Installed:		1995
	Typical Service Life (years):		40
	Effective Age (years):		30
	Remaining Service Life (years):		10
	Planned Renewal Date:		2035
<p>Description: This item includes the vinyl cladding on all the townhouses throughout the property.</p> <p>Condition: The vinyl cladding is in reasonable condition with no reports or observations of water ingress. As mentioned in item #7, general building envelope repairs have been conducted as an ongoing maintenance item.</p> <p>Comments: The reserve costs include the renewal of the vinyl cladding on the townhouses. This item should be included in the BECA mentioned in item #6.</p>

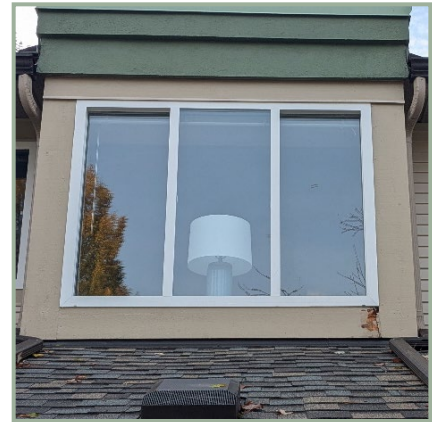
10 WINDOW ASSEMBLIES (CONDOS)	
BUILDING ENVELOPE AND STRUCTURE	Location: Building exterior of condos
	Year Installed: 2007
	Typical Service Life (years): 30
	Effective Age (years): 18
	Remaining Service Life (years): 12
	Planned Renewal Date: 2037
	<p>Description: This item includes all the windows installed on the Mayfair, Kensington and Windsor condo buildings and the Clubhouse building.</p> <p>Condition: The windows are in reasonable condition with no observations or reports of deficiencies. It was noted that these windows were replaced during the envelope remediation project in 2007.</p> <p>Comments: The reserve costs include the full renewal of the windows on the condo buildings.</p>

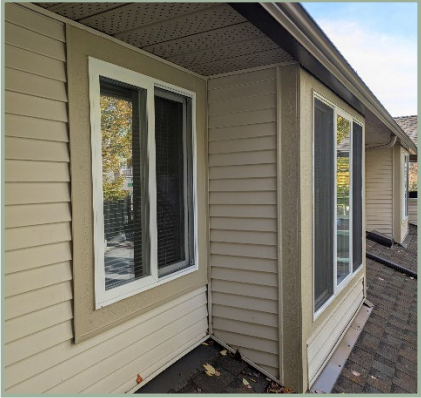
11 WINDOW ASSEMBLIES (TOWNHOUSES)			
BUILDING ENVELOPE AND STRUCTURE	Location:	Building exterior of townhouses

Year Installed:	1995	
	Typical Service Life (years):	30	
	Effective Age (years):	25	
	Remaining Service Life (years):	5	
	Planned Renewal Date:	2030	
	Description: This item includes all the windows installed on the townhouses.		
Condition: The windows are in reasonable condition with no observations or reports of water ingress in the glazing units or frames. It was noted that some of these windows have been replaced on an as-needed basis since 2017.			
Comments: The reserve costs include the renewal of all the windows on the townhouses. These windows should be included in the BECA mentioned in item #6 to better determine its remaining service life.

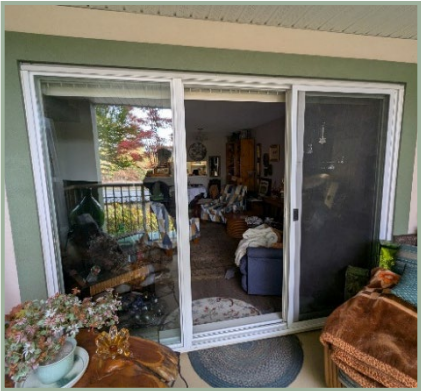
Year Installed:	2007	
	Typical Service Life (years):	30	
	Effective Age (years):	18	
	Remaining Service Life (years):	12	
	Planned Renewal Date:	2037	
	Description: This item includes all the sliding doors used to access condo decks and balconies.		
Condition: The sliding doors are in reasonable condition. It was noted that these sliding doors were replaced during the envelope remediation project in 2007.			
Comments: The reserve costs include the renewal of the sliding doors on the condos.

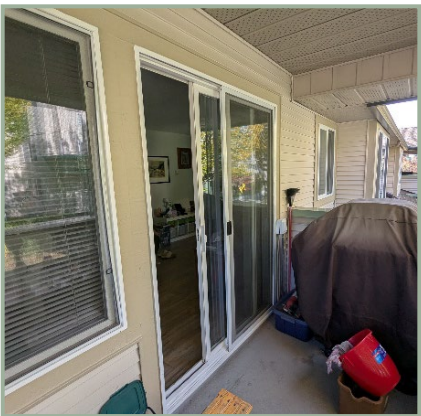
Year Installed:	1995	
	Typical Service Life (years):	30	
	Effective Age (years):	25	
	Remaining Service Life (years):	5	
	Planned Renewal Date:	2030	
	<p>Description: This item includes all the sliding doors used to access the decks in the townhouses.</p> <p>Condition: The sliding doors are in reasonable condition with no reports of deficiencies.</p> <p>Comments: The reserve costs include the full renewal of the sliding doors. These sliding doors should be included in the BECA mentioned in item #6 to better determine its remaining service life.</p>

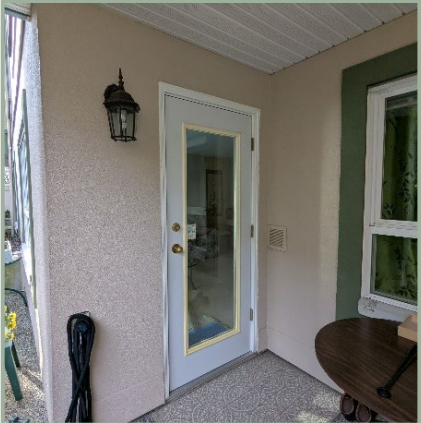
Year Installed:	1995	
	Typical Service Life (years):	30	
	Effective Age (years):	25	
	Remaining Service Life (years):	5	
	Planned Renewal Date:	2030	
	<p>Description: This item includes all the swing doors used to access the balconies and decks on the Kensington, Mayfair Windsor condo buildings.</p> <p>Condition: The swing doors are in operable condition with no reports or observations of deficiencies.</p> <p>Comments: The reserve costs include the partial renewal of the swing doors. The swing doors for the condo should be included in the BECA mentioned in item #6 to better determine its remaining service life.</p>

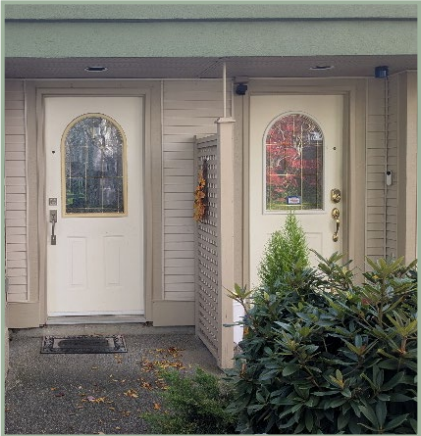
Year Installed:	1995	
	Typical Service Life (years):	30	
	Effective Age (years):	25	
	Remaining Service Life (years):	5	
	Planned Renewal Date:	2030	
	<p>Description: This item includes all the entry doors that are used to access the townhouses. This includes both the front and side entry doors.</p> <p>Condition: The entry doors are in fair condition with no observations or reports of deficiencies. It was noted that these entry doors may have been replaced as requested by the owners.</p> <p>Comments: The reserve costs include full renewal of the entry doors to the townhouses. These entry doors should be included in the BECA mentioned in item #6 to better determine its remaining service life.</p>

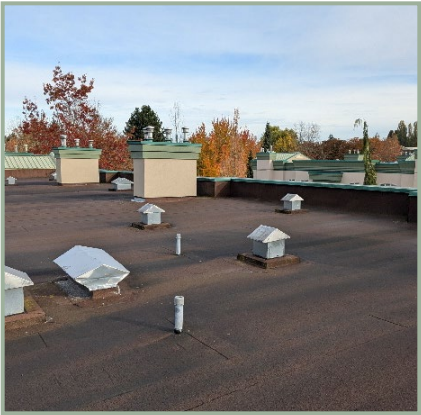
BUILDING ENVELOPE AND STRUCTURE	Location:		Above the condo buildings
	Year Installed:		1995
	Typical Service Life (years):		25
	Effective Age (years):		24
	Remaining Service Life (years):		1
	Planned Renewal Date:		2026
<p>Description: This item includes all the SBS torch-on low-slope roofing above the condo buildings.</p> <p>Condition: The low-slope roofs are in poor condition. General observations of staining, debris accumulation and hardened roofing membrane were made. Additionally, major ponding was observed on the roof of the Mayfair building. It was noted by the strata president that the low-slope roofs are planned to be replaced starting in 2026.</p> <p>Comments: The reserve cost includes fully replacing the low-slope roofing with the industry standard 2-Ply SBS roofing, which includes the metal flashing around the roof edges.</p>

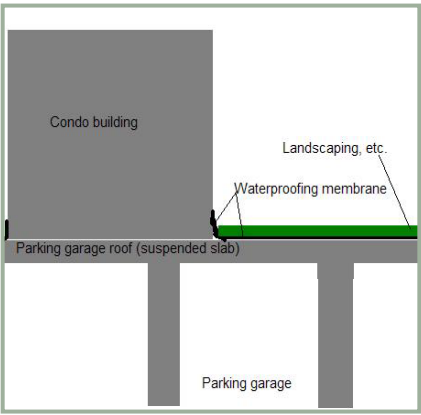
BUILDING ENVELOPE AND STRUCTURE	Location:	Above parkade suspended slabs	
	Year Installed:	1995	
	Typical Service Life (years):	50	
	Effective Age (years):	30	
	Remaining Service Life (years):	20	
	Planned Renewal Date:	2045	
	<p>Description: This item includes the below-grade waterproofing membrane above the parkade suspended slab and underneath landscaping or hardscaping. This membrane is designed to protect the parkade underneath from water ingress.</p> <p>Condition: The below-grade membrane could not be visually reviewed with a non-exploratory review.</p> <p>Comments: The reserve cost includes the renewal of the below-grade membrane. An allowance has been made in 2035 for a percentage of the reserve cost for a condition assessment and potential targeted repair work. Additionally, another allowance has been made three years prior to the renewal year for a condition assessment and targeted repair work to better determine the condition of the below-grade waterproofing membrane and the scope of the renewal work needed.</p>

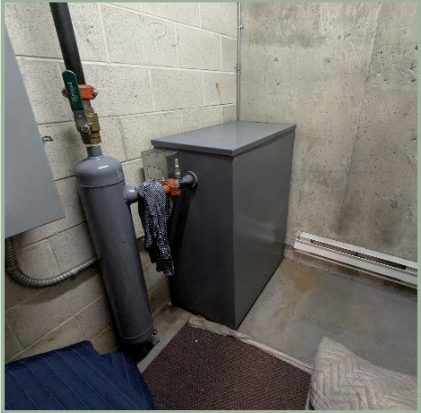
Description: This item includes the three hydraulic elevators servicing the three condo buildings.	
Condition: The integrity and condition of this asset cannot be verified without a professional engineer. At the time of the site visit, the elevators were in operable condition with no observable deficiencies.	
Comments: The reserve costs include the modernization plan for the three hydraulic elevators. The strata president reported that it is in the elevator contractor’s opinion that a modernization plan is unnecessary; however, to stay prudent of the potential failures of these elevators and the renewal project that may follow, we have included the modernization project to occur in the next 5 years. A condition assessment and engineering overview is recommended before the project is initiated. Extra allowance has been made for the engineering review in 2027.

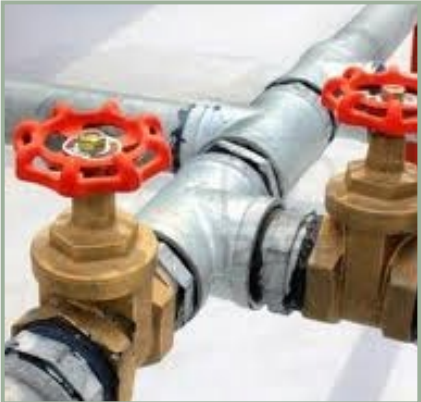
Year Installed:	1995	
	Typical Service Life (years):	30	
	Effective Age (years):	27	
	Remaining Service Life (years):	3	
	Planned Renewal Date:	2028	
	<p>Description: This item includes all the domestic water lines installed within common walls to distribute water to units in the condos. This also includes the domestic water lines between the shared walls in townhouses.</p> <p>Condition: The condition of the pipes could not be verified with a non-exploratory visual review.</p> <p>Comments: For the distribution piping, plumbing issues are often the result of local water chemistry (low pH and relatively soft water), which contributes to corrosion in copper piping followed by pinhole leaks. The cost of this item is based on the number of units and recommends full scale renewal. Renewal costs do not include all interior work (e.g. drywall, paint, texturing and finishes), which may vary substantially based on code updates, and material compatibilities, etc. Extra allowance was allotted in 2027 for a plumbing assessment and targeted repairs to prepare for the potential large-scale plumbing renewal in 2028 (the scope of renewal will be dependent on plumbing assessment findings).</p>
