# **DEPRECIATION REPORT CHELSEA GARDENS (2021 UPDATE)**

13860 – 13888 70<sup>th</sup> Avenue  
Surrey, British Columbia

Report No. 1433.DR00

July 6, 2021

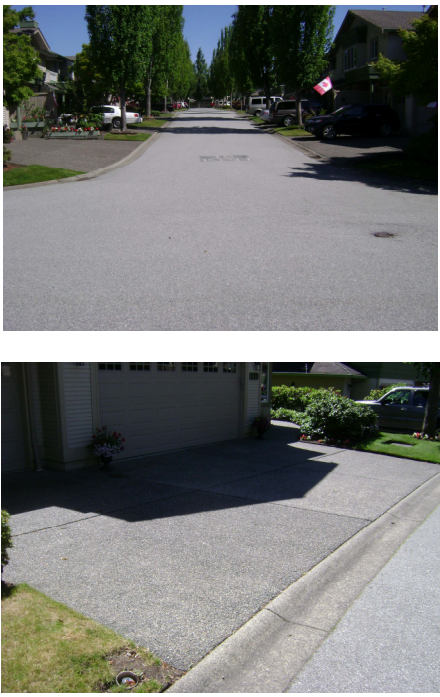
<b>Item:</b>	<b>Site 2</b>
	<b>Description:</b>	Roads, Visitor parking, Curbs, Driveways, Parking Garage Entrance Driveway
	<b>Location:</b>	Roads and Curbs – through complex Visitor Parking – throughout complex, RV lot (south end of complex) Driveways – townhouse units Parking Garage Entrance Driveway – Buildings '60, '70, '80
	<b>Current Age:</b>	26 years
	<b>Service Life:</b>	35 years
<b>Assessment:</b>	<p>The existing roads and visitor parking throughout the complex are paved with asphalt; roundabouts and parking at the front of the complex are covered with paving stones; the townhouse driveways and parking garage entrance driveways are concrete.</p> <p>The asphalt/concrete surfaces were in reasonable condition. Minor cracking of the asphalt surfaces and concrete ramps was observed throughout the complex. The painted markings throughout the complex have faded. No significant damage was observed.</p>

<b>Recommendation:</b>	<p>The roadways/driveways should continue to be monitored. Localized maintenance &amp; repairs are recommended to any sections of roadway and driveway which are cracked/damaged. Such repairs may be periodically required to extend the service life. We have included an allowance in the table for future repairs, on an as-needed basis. Re-painting of all faded markings should also be completed (operating budget).</p> <p>The cost for eventual replacement of the entire asphalt paved roadway, including the RV lot, has also been included based on expected service life.</p>

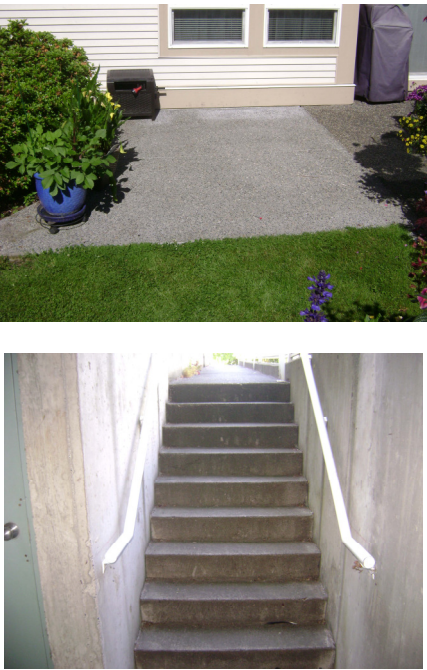
<b>Item:</b>	<b>Site 3</b>
	<b>Description:</b>	Walkways, Sidewalks, Patios & Stairs (on grade)
	<b>Location:</b>	Designated walkways/sidewalks – throughout complex and along side of townhouses  Patio – at the backyard of all townhouse  Stairs – to underground parking garage and sidewalks
	<b>Current Age:</b>	26 years (concrete topping)
	<b>Service Life:</b>	N/A
<b>Assessment:</b>	<p>Designated walkways and/or sidewalks are located throughout the complex as well as from the driveways to the front entrances of the townhouse units (some of which lead to the back patios). The walkways/sidewalks consist of concrete topping, or paving stones, and are exposed to the elements.</p> <p>The patios are located the back of the townhouse units and consist of concrete topped slabs. The patios are exposed to the elements.</p> <p>Exterior concrete stairs lead to the underground parking garage of Buildings '60, '70 &amp; '80 and to the sidewalks. These stairs are exposed to the elements.</p> <p>The walkway/sidewalk and patio surfaces, along with the stairs, were, generally, in reasonable condition for their age with no significant problems/major deficiencies noted or reported such as damage or uplifting.</p>

<b>Recommendation:</b>	<p>The walkway/sidewalk and patio slabs, along with the stairs should be monitored and addressed, as required. Minor, localized repairs may be required from time to time (in areas of cracking, settling and uplifting or tripping hazards) to extend the serviceable life, as these items continue to age. We have included a contingency allowance in the table for ongoing localized repairs.</p>

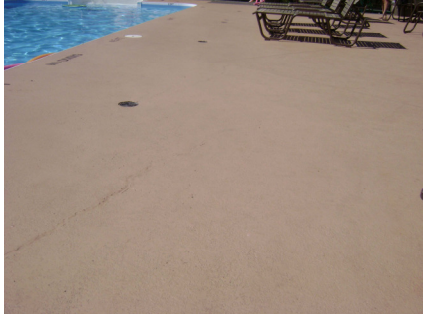
<b>Item:</b>	<b>Site 4</b>
	<b>Description:</b>	Concrete (pool deck)
	<b>Location:</b>	Building '88 – outdoor pool deck
	<b>Current Age:</b>	26 years (concrete topping)
	<b>Service Life:</b>	5 years (coating)
<b>Assessment:</b>	The concrete floor around the outdoor pool is painted. Some cracking of the concrete surface, and peeling of the surface coating, was noted. The pool deck is exposed to the elements.	
<b>Recommendation:</b>	The pool deck surface should be re-painted/sealed and monitored. We have included an allowance in the table for this work. Minor, localized repairs may be required from time to time (such as crack repairs) to extend the serviceable life

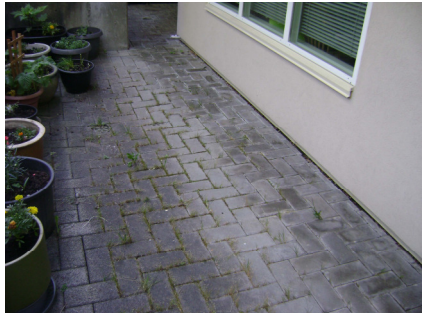
<b>Item:</b>	<b>Site 5</b>
	<b>Description:</b>	Patios, Walkways & Sidewalks (over parking garage)
	<b>Location:</b>	Patios - ground floor units of Buildings '60, '70 & '80  Walkways/Sidewalks – around Buildings '60,'70 &'80
	<b>Current Age:</b>	26 years (waterproofing membrane)
	<b>Service Life:</b>	35 years (waterproofing membrane)
<b>Assessment:</b>	<p>The ground floor patios and some walkways/sidewalks are mostly located directly over the parking garage of Buildings '60, '70 &amp; '80. The patios are covered in concrete topping (Buildings '60 &amp; '80) or pavers (Building '70) and are open to the elements with some protection from the balconies above.</p> <p>According to the architectural drawings, below the concrete topping/pavers is pea gravel, protection board and waterproofing membrane. The waterproofing membrane below the patios, walkways and sidewalks is original. The type of waterproofing membrane was not specified in the drawings.</p> <p>Aside from some minor hairline cracking, no significant</p>

<p>problems/major deficiencies on the patio/walkway/sidewalk surfaces (such as settling, damage or uplifting of the concrete topping) were reported or observed.</p> <p>Also refer to Encl. 18 Underground Parking Garage for further observations of the parking garage below the patio, walkway and sidewalk areas.</p>
<b>Recommendation:</b>	<p>The patio, walkway and sidewalk slabs above the parking garage should be monitored and addressed (operating budget), where required, especially if they start to present a tripping hazard which is a safety issue. Minor repairs, such as sealing surface cracks may be required from time to time. All patio surfaces and drains should also be kept clear of debris. No allowance has been made in the table.</p> <p>The underground parking garage should be monitored for any leaks directly under the patio, walkways and sidewalks. Refer to Encl 18 Underground Parking Garage for further recommendations and replacement costs of the parking garage membrane.</p>

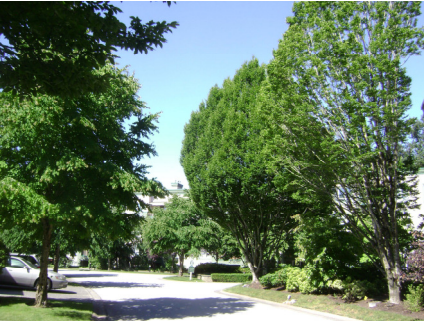
<b>Item:</b>	<b>Site 6</b>
	<b>Description:</b>	Landscaping (various)
	<b>Location:</b>	Grounds around building (including over parking garage)
	<b>Current Age:</b>	N/A
	<b>Service Life:</b>	N/A
<b>Assessment:</b>	<p>Various vegetation such as ground cover, shrubs, plants and trees make up the soft landscaping throughout the complex. Some larger trees are located in front of some townhouse units and around the perimeter of the complex. There are also designated planters located around the perimeter of the apartment buildings, over the parking garage. Landscaping ties are also being used at walkways and for retaining walls.</p> <p>The landscaping appears to be in acceptable condition with no major deficiencies observed or reported. The Strata currently has a service contract for landscaping services.</p>	
<b>Recommendation:</b>	<p>Routine maintenance and repair/replacement of landscaping and related components should be completed as required. We have included an allowance in the table for miscellaneous landscaping</p>

<p>replacement and ongoing selective repairs of existing wood ties/retaining walls on an as-needed basis.</p> <p>The Strata should be aware of, and monitor, any larger trees, whose roots have a potential to damage the existing waterproofing membrane over the parking garage and/or potentially uplift the concrete/asphalt topped areas around the complex. These areas should be addressed on an as-needed basis (operating budget). The Strata should also be aware of any shrubs, trees and branches up against the exterior walls. The Strata should keep vegetation, shrubs, trees and branches trimmed back from contact with the exterior walls (operating budget).</p>
--	--

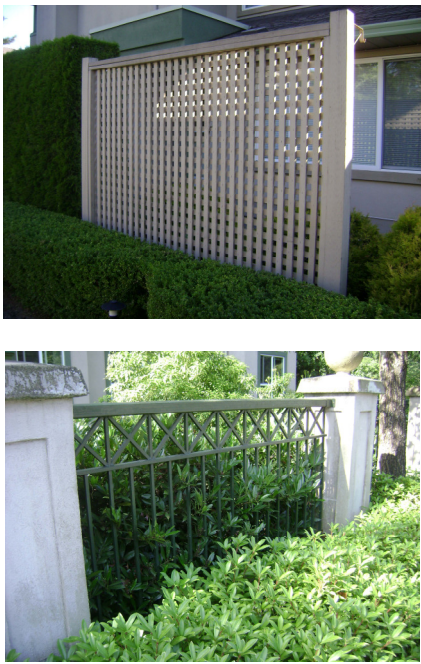
<b>Item:</b>	Site 7
	<b>Description:</b>	Fencing & Railings
	<b>Location:</b>	Around complex, throughout complex
	<b>Current Age:</b>	Varies
	<b>Service Life:</b>	N/A

<b>Assessment:</b>	<p>Wood lattice panels are located between some units along the front of the townhouses. Some townhouses also have privacy fencing at the end of the units, around the back patios and along walkways. Privacy fencing is also located on one side of the RV lot. The wood fencing has been maintained, repaired or replaced over the years. The wood fencing is been painted.</p> <p>Concrete fence/panels and posts w/caps are original and located around the perimeter of the complex (north, west and east sides). The panels and posts are parged with stucco.</p> <p>Sections of metal fencing and gates are original and located around the perimeter of the complex (north, west and east sides), primarily between the concrete posts. Chainlink fencing is located around</p>
--------------------	--

<p>the RV lot at the south end of the complex.</p> <p>Metal picket and glass panel railings are located adjacent and above the parkade ramps/entrances, at exterior stairs and around the pool at Building '88.</p> <p>Overall, the fencing, gates and railings appear to be in sound condition with no major evidence of instability.</p>
<p><b>Recommendation:</b></p>	<p>Replacement of wood fencing and lattice panels has been ongoing, annually, out of operating budget, on an as-needed basis. The wood fencing should continue to be monitored. Continue with annual replacement, on an as-needed basis (operating budget). No allowance has been made in the table.</p> <p>Concrete fence/panels and posts should be monitored and regularly maintained as required (operating budget). Minor repairs, such as, spot repairs to the stucco parging, spot painting and cleaning should be completed on an as-needed basis (operating budget). We have included an allowance in the table for re-painting all of the concrete fence/panels and posts.</p> <p>The metal fencing, gates and railings should be monitored and regularly maintained as required (operating budget). Minor repairs, such as spot painting or touch-up, may be required from time to time, to maintain the finish and prevent any rusting.</p>

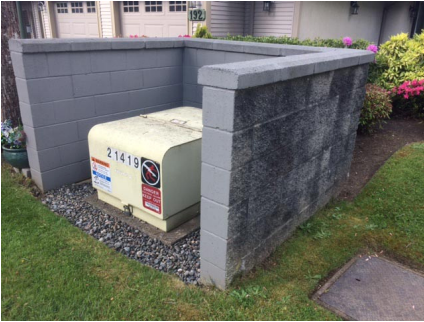
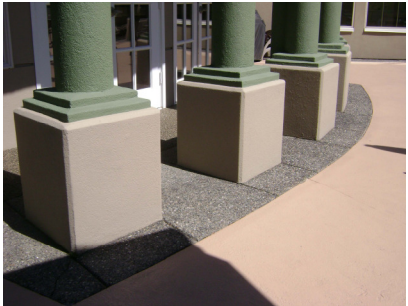
<p><b>Item:</b></p>	<p><b>Site 8</b></p>

<p><b>Description:</b></p>	<p>Concrete/Block Walls</p>
	<p><b>Location:</b></p>	<p>Buildings '60,'70,'80,'88, TH – column bases, retaining walls, around electrical boxes</p>
	<p><b>Current Age:</b></p>	<p>26 years</p>
	<p><b>Service Life:</b></p>	<p>10 years (paint)</p>

<b>Assessment:</b>	Overall, no significant deficiencies of the concrete column bases, retaining walls and block walls were noted. Some of the column bases are painted. Re-painting and spot repairs were completed in 2017.
<b>Recommendation:</b>	Monitoring of the concrete column bases, retaining walls and block walls should be ongoing (operating budget). Minor repairs, such as sealing cracks, or replacing cracked blocks, may be required from time to time, the cost of which should be part of the operating budget. We have included a future allowance for painting.

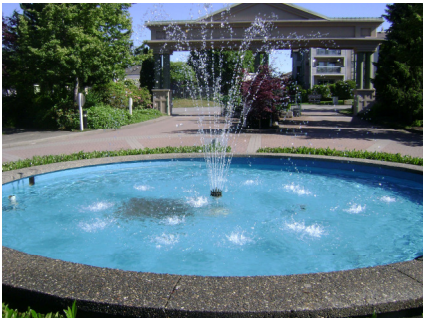
<b>Item:</b>	<b>Site 9</b>
	<b>Description:</b>	Outdoor Fountains/Ponds
	<b>Location:</b>	At front entrance of complex and at Buildings '60,'70,'88
	<b>Current Age:</b>	26 years
	<b>Service Life:</b>	5 years (paint)
<b>Assessment:</b>	<p>There are multiple outdoor fountains at the complex. There are also ponds and a stream behind the Clubhouse.</p> <p>The outdoor fountains are concrete structures with painted walls on the inside, last painted in 2017.</p> <p>There is a stream and two ponds behind the Clubhouse. The stream is lined with a rubber liner. The ponds are concrete structures, presumably protected by a sealer. No problems were noted or reported.</p>	
<b>Recommendation:</b>	<p>Regular maintenance to the fountains &amp; ponds should ongoing and completed (at least annually), which includes draining the pond, removing all debris and cleaning the drains/outlets (operating budget). The liner should last for the foreseeable future, therefore, replacement is not included in the table. We have, however, allowed for re-painting of the inside walls of the fountains.</p>

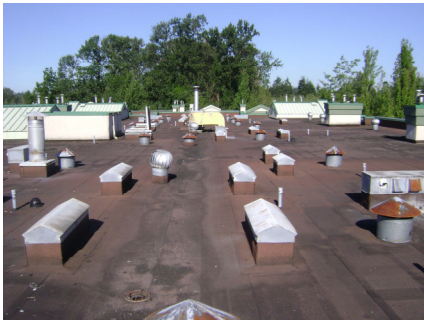
<b>Item:</b>	<b>Encl 1</b>
	<b>Description:</b>	Flat Roofs (SBS membrane)
	<b>Location:</b>	Buildings '60, '70 & '80 – Above fourth floor units, lower small roofs, front entrance roofs, elevator roofs  Building '88 – Above second & third floors  TH – Above first floor
	<b>Current Age:</b>	26 years (Buildings '60, '70, '80 & '88)  Varies (2019-current) – TH
	<b>Service Life:</b>	30 years (TH)  35 years (Buildings '60, '70, '80 & '88)
<b>Assessment:</b>	<p>Access to the flat roof areas is by ladder from the 4th floor hallways. Access to the Clubhouse roofs is by 2<sup>nd</sup> floor access door and ladder. Access to the Townhouse roofs is by ladder.</p> <p>The existing flat roofs consist of an SBS membrane (with granulated cap sheet) and are original on the apartment buildings and appear to be in fair condition for their age, with no signs or reports of water ingress. Minor repairs have been ongoing.</p> <p>Replacement of the SBS flat roof membranes on the townhouse units is ongoing.</p>

<b>Recommendation:</b>	<p>Expected service life of the apartment roof membranes should be attained with regular inspections and minor repairs as required (operating budget). Future membrane replacement has been allowed for based on expected service life. An ongoing allowance for replacement of the townhouses flat roofs has been included.</p>

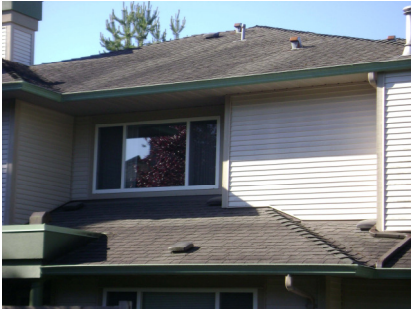
<b>Item:</b>	<b>Encl 2</b>
	<b>Description:</b>	Sloped Roofs (asphalt shingles)
	<b>Location:</b>	Townhouses
	<b>Current Age:</b>	26 years
	<b>Service Life:</b>	35 years
<b>Assessment:</b>	<p>The asphalt shingles are original and appear to be in reasonable condition for their age, with no signs or reports of water ingress. Some moss growth was observed on the roof surfaces (particularly the north sides) as well as under the some of the larger trees. Some of the roof vents were also rusted. The sloped roofs provide adequate overhangs over the first and second floor walls, windows and decks.</p>	
<b>Recommendation:</b>	<p>Expected service life should be attained with regular inspections and routine maintenance such as regular cleaning of the gutters, removing moss from the roof surface and re-painting all rusted roof vents along with regular inspections, with minor repairs as required (operating budget). Cost for future replacement has been included in the table, spread over four years.</p>

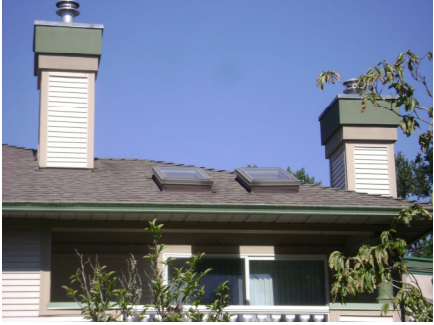
<b>Item:</b>	<b>Encl 3</b>
	<b>Description:</b>	Skylights (sloped roof)
	<b>Location:</b>	Townhouses – upper roofs
	<b>Current Age:</b>	26 years
	<b>Service Life:</b>	30 years
<b>Assessment:</b>	<p>The sloped roof skylights are original and are located over the open townhouse roof decks.</p>	
<b>Recommendation:</b>	<p>The existing skylights should be reviewed regularly and maintained as required (operating budget). These skylights should be replaced in the future in conjunction with future replacement of the sloped roof shingles (spread over three years). A replacement cost has been included in item Encl 2.</p>

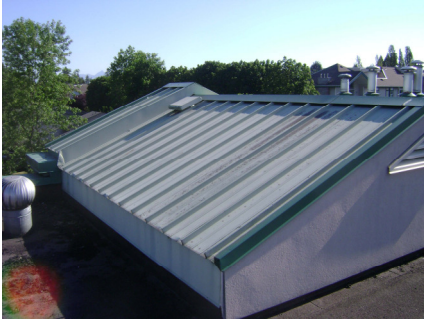
<b>Item:</b>	<b>Encl 4</b>
	<b>Description:</b>	Sloped Roofs (metal)
	<b>Location:</b>	Entrance canopies (off street) Buildings '60, '70 & '80 – Above fourth floor units on main flat roof Building '88 – Above second floor on main flat roof & above third floor
	<b>Current Age:</b>	26 years
	<b>Service Life:</b>	40 years
<b>Assessment:</b>	The numerous, small sloped metal roof sections were in reasonable/satisfactory condition for their age with no signs or reports of water ingress.	
<b>Recommendation:</b>	Expected service life should be attained with routine maintenance, such as replacement of rusted fasteners, spot painting and regular cleaning along with regular inspections, with minor repairs as required (operating budget). Future replacement has been allowed for based on expected service life.

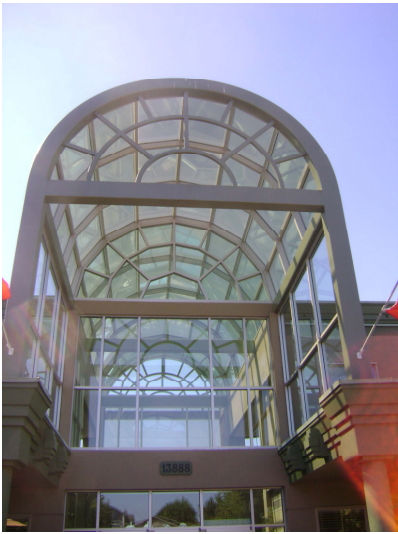
<b>Item:</b>	<b>Encl 5</b>
	<b>Description:</b>	Glass Canopy
	<b>Location:</b>	Building '88 - Main entrance & lobby
	<b>Current Age:</b>	26 years
	<b>Service Life:</b>	N/A
<b>Assessment:</b>	There is a large steel frame canopy w/glass panels over the main entrance and lobby of the Clubhouse building (Building '88). This structure is performing adequately and in satisfactory condition. No problems were noted or reported.

<b>Recommendation:</b>	The existing canopy should be reviewed regularly and maintained, as required, including caulking, seals and regular cleaning, to help extend its life (operating budget). Touch up painting may be required from time to time to prevent rust and maintain the finish, and should be reviewed at the same time as other painting is completed around the complex. No allowance has been made in the table.
------------------------	--

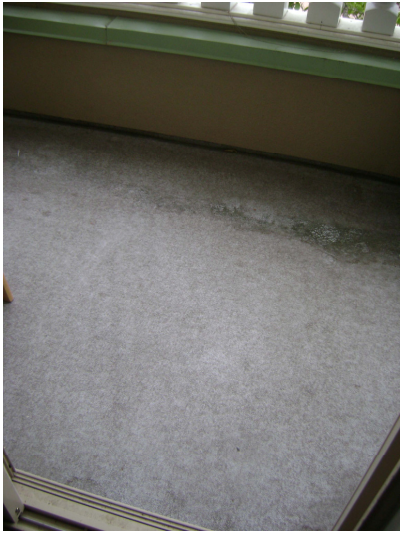
<b>Item:</b>	<b>Encl 6</b>
	<b>Description:</b>	Roof Decks - balconies over living spaces (PVC membrane)
	<b>Location:</b>	Townhouses
	<b>Current Age:</b>	22 years
	<b>Service Life:</b>	30 years

<b>Assessment:</b>	<p>The second floor townhouse roof decks are located at either the front or back of the units. Some units have two roof decks; some units don't have any. The roof decks are open to the elements but protected from the sloped roof above.</p> <p>The existing PVC membranes are original, however, some selective membrane repairs were completed in 2009, during building envelope repairs at Units 169-174, 197-201, 203-208 &amp; 231-236.</p> <p>Overall, the existing roof deck membranes on the townhouse units are in satisfactory condition for their age and performing adequately with no reports of current or ongoing leakage activity.</p> <p>Each roof deck has a drain connected to internal plumbing. The decks are, generally, sloped towards the drain.</p> <p>The roof decks have full height vinyl siding or stucco clad guard walls with a section of wood picket rail in the middle of the guard wall.</p>

<b>Recommendation:</b>	The membranes are performing adequately and in satisfactory condition, partially due to the fact that the roof decks are protected from the elements. Therefore, the membranes should be
------------------------	--

<p>monitored, maintained and addressed as required (operating budget).</p> <p>We have included future cost allowance to replace the existing PVC membranes, on an as-needed basis.</p>
--	--

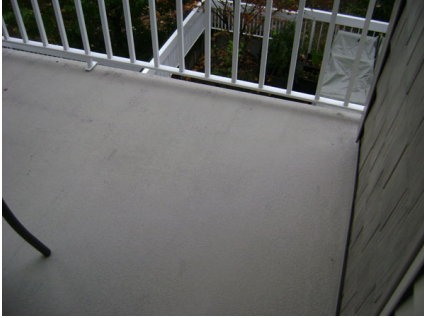
<b>Item:</b>	<b>Encl 7</b>
	<b>Description:</b>	Balconies (pedestrian liquid membrane)
	<b>Location:</b>	Buildings '60, '70, '80 & '88
	<b>Current Age:</b>	Buildings '60 & '80 – 2008 (9 years) Building '70 – 2007 (10 years) Building '88 – 2009 (8 years)
	<b>Service Life:</b>	12-15 years (top coat)

<b>Assessment:</b>	<p>The balcony membranes on Buildings '60, '70, '80 &amp; '88 were replaced between 2007-2009, as part of the building envelope remediation.</p> <p>The second and third floor balconies are, generally, open to the elements but protected from the balconies above. The fourth floor balconies are exposed.</p> <p>The balcony membranes appear to be performing adequately with no signs or reports of water ingress. The membranes on some of the fourth floor exposed decks, however, are starting to show wear. It should be noted that the original membrane top coat is now 8-10 years old.</p> <p>Each balcony has a drain connected to internal plumbing. The balconies are, generally, sloped towards the drain.</p> <p>The existing guard walls, typically, consist of full height metal picket railings that are fascia or side mounted to the balcony structure or curb wall and installed between full height stucco clad support posts or wrap around the balcony.</p>

<b>Recommendation:</b>	<p>The typical life expectancy of a liquid applied membrane (top coat) is approximately 12-15 years depending on the membrane thickness, waterproofing details and the exposure of the deck. Over the years, the membrane top coat tends to wear down from</p>
------------------------	--

<p>foot traffic, weather, exposure, etc. As part of ongoing maintenance, we recommend applying a new, compatible top coat over the existing to build up, maintain and extend the life of the existing membrane, particularly on the exposed decks. An allowance for this work has been included for in the table every 12 years, starting in 2025.</p> <p>The balconies should be inspected regularly. As part of the operating budget, routine maintenance such as cleaning of the membrane surface and drains, and re-caulking of cap flashings seams &amp; penetrations should be completed as required. Furniture should be placed on rubber pads to prevent damage to the membrane.</p>
--	--

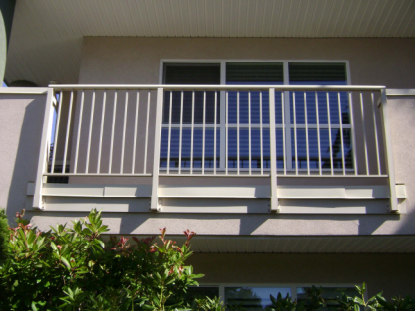
<b>Item:</b>	<b>Encl 8</b>
	<b>Description:</b>	Balcony Guardrails (aluminum picket or glass)
	<b>Location:</b>	Buildings '60, '70 & '80 & TH
	<b>Current Age:</b>	Buildings '60 & '80 – 2008 (13 years) Building '70 – 2007 (14 years) TH – varies/ongoing
	<b>Service Life:</b>	50 years

<b>Assessment:</b>	<p>The existing railings on the apartment balconies consist of aluminum pickets and posts. They were installed in 2007-2008 as part of the building envelope remediation. The railings are either fascia mounted or side mounted to the deck structure or curb wall. They are in satisfactory condition with no problems reported or observed.</p> <p>On the townhouses, annual (ongoing) replacement of the existing wood spindles, with new glass panel, aluminum railings is ongoing.</p>
--------------------	--

<b>Recommendation:</b>	<p>Minimal maintenance of the aluminum guardrails is expected, however, they should be checked as part of the overall deck review and maintained out of the operating budget as required, such as caulking, paint finish and fasteners. Replacement is based on the expected service life and therefore not included in the 30-year Table.</p> <p>Replacement of the wood spindles on the townhouse balconies,</p>
------------------------	--

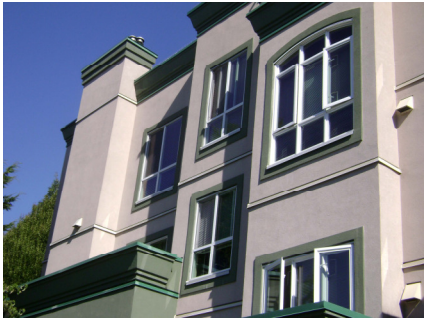
<b>Item:</b>	<b>Encl 9</b>
	<b>Description:</b>	Exterior Walls (stucco)
	<b>Location:</b>	Buildings '60, '70, '80, '88 & TH
	<b>Current Age:</b>	26 years (original cladding) 12-14 years (2007-2009)(rainscreen cladding)
	<b>Service Life:</b>	50 years 12-15 years (paint)

<b>Assessment:</b>	<p>The exterior stucco walls (Buildings '60, '70, '80, '88 (selective locations) and townhouses (selective locations)) were replaced with a new rainscreen stucco system between 2007-2009, as part of the building envelope remediation. There were no reported or observed problems. As a follow-up, MVL conducted a survey in February 2016 of the moisture sensors installed at the buildings (refer to MVL's report dated February 29, 2016). A total of 101 readings were taken with all moisture readings being acceptable.</p> <p>Most of the townhouse units have the original stucco cladding which appeared to be in satisfactory condition with no reported problems of water ingress.</p> <p>The existing caulking at Buildings '60, '70, '80, '88 and townhouses (at previously repaired areas) was in satisfactory condition.</p> <p>The existing caulking at original stucco clad areas (eg. interfaces, window/door perimeters at townhouses) was in reasonable condition in protected locations, however the caulking at many exposed locations was cracked, hardened and/or delaminated.</p> <p>No other problems were visually noted or reported.</p>

<b>Recommendation:</b>	<p>All stucco areas should be monitored and maintained, as required (operating budget). Minor items to be addressed may include sealing all stucco cracks and selective caulking. Exterior cleaning of the stucco should also be completed as required. With routine maintenance and repairs, the life of the stucco walls should be able to be extended, therefore, total replacement cost has not been</p>
------------------------	--

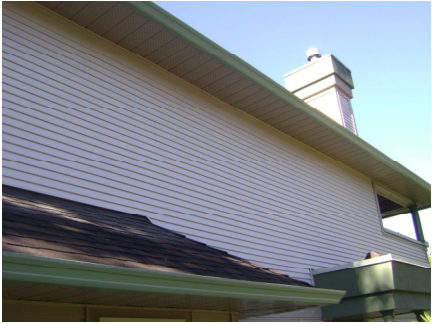
<b>Item:</b>	<b>Encl 10</b>
	<b>Description:</b>	Exterior Walls (horizontal vinyl siding)
	<b>Location:</b>	TH
	<b>Current Age:</b>	Varies
	<b>Service Life:</b>	50 years
<b>Assessment:</b>	<p>Most of the vinyl siding on the townhouses is original and appeared to be in satisfactory condition. Selective ongoing building envelope related repairs have been ongoing over the years. No invasive testing of the cladding was conducted.</p> <p>The existing caulking at the vinyl siding (eg. interfaces, window/door perimeters) was in reasonable condition in protected locations, however the caulking at many exposed locations was cracked, hardened and/or delaminated.</p>	
<b>Recommendation:</b>	<p>The vinyl siding should be monitored and maintained, as required, (operating budget), including exterior cleaning.</p> <p>The existing caulking should be addressed, particularly at the exposed locations. We have included a contingency allowance for re-caulking the exterior of the townhouse units in item Encl 11.</p>

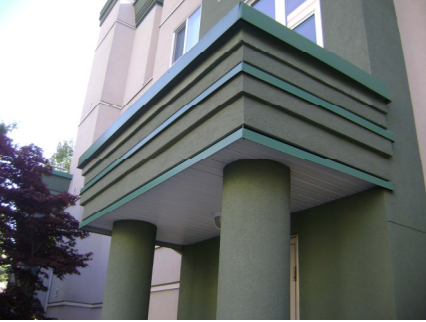
<b>Item:</b>	<b>Encl 12</b>
	<b>Description:</b>	Exterior Walls (EIFS)
	<b>Location:</b>	Buildings '60, '70, '80, '88 & TH
	<b>Current Age:</b>	26 years (original cladding) 12-14 years (2007-2009)(selective repairs)
	<b>Service Life:</b>	50 years 12-15 years (paint)
<b>Assessment:</b>	EIFS (Exterior Insulated Finish System) is installed around windows and doors (trim), at roof cornices and around support columns. Selective replacement of this trim was completed in 2007-2009 during the building envelope remediation. There were no reported or observed problems.	
<b>Recommendation:</b>	<p>All EIFS areas should be monitored and maintained, as required (operating budget). Minor items to be addressed may include sealing cracks and selective caulking. With routine maintenance and repairs, the life of the EIFS should be able to be extended, therefore, total replacement cost has not been included in the table.</p> <p>We have included a contingency allowance for painting all EIFS</p>

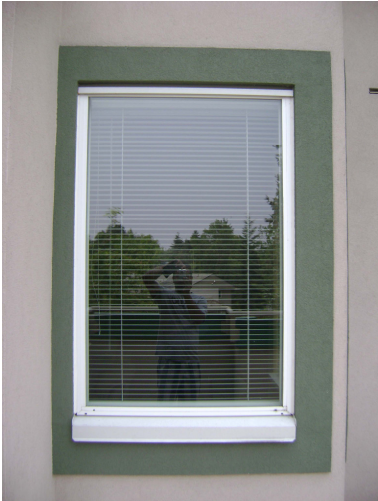
<b>Item:</b>	<b>Encl 13</b>
	<b>Description:</b>	Windows (PVC, double glazed)
	<b>Location:</b>	Buildings '60, '70, '80, '88 & TH
	<b>Current Age:</b>	Buildings '60 & '80 – 13 years (2008) Building '70 – 14 years (2007) Building '88 – 12 years (2009) or 26 years TH – Varies or 26 years
	<b>Service Life:</b>	35 years

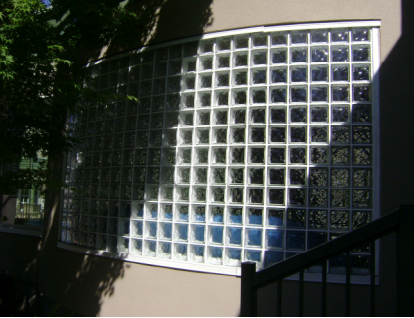
<b>Item:</b>	<b>Encl 14</b>
	<b>Description:</b>	Windows (glass block)
	<b>Location:</b>	Building '88 (south elevation)
	<b>Current Age:</b>	13 years (2009)
	<b>Service Life:</b>	N/A
<b>Assessment:</b>	<p>The glass block units were replaced during the building envelope remediation in 2009.</p> <p>The glass block units are in satisfactory condition with no problems reported or observed. They should not require replacement in the foreseeable future.</p>	
<b>Recommendation:</b>	<p>With routine maintenance, like re-grouting, the glass block units should not require replacement unless physically damaged. Therefore, no allowance has been made in the table. Periodic inspections should be ongoing.</p>

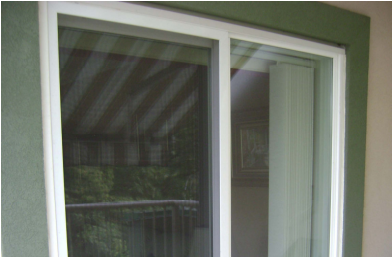
<b>Item:</b>	<b>Encl 15</b>
	<b>Description:</b>	Sliding Doors (PVC, double glazed)
	<b>Location:</b>	Buildings '60, '70, '80, '88 & TH
	<b>Current Age:</b>	Buildings '60 & '80 – 13 years

A cost to replace the existing caulking around the sliding doors has been included in Encl 9.
--	---

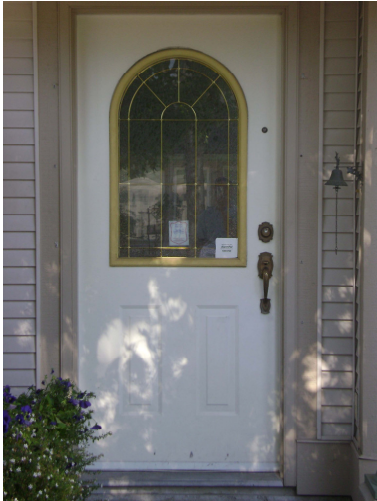
<b>Item:</b>	<b>Encl 16</b>
	<b>Description:</b>	Doors (casement/swing)
	<b>Location:</b>	Buildings '60, '70, '80, '88 & TH  Front entry, unit entrances, balcony, patio and pool access, parkade exits, service rooms
	<b>Current Age:</b>	Varies
	<b>Service Life:</b>	Varies

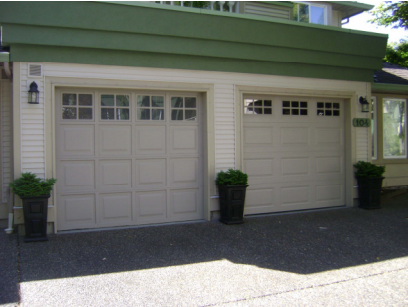
<b>Item:</b>	<b>Encl 17</b>
	<b>Description:</b>	Doors – Garage
	<b>Location:</b>	Townhouses
	<b>Current Age:</b>	Varies
	<b>Service Life:</b>	20 years
<b>Assessment:</b>	The original townhouse garage doors are wood. Replacement of these doors has been ongoing.	
<b>Recommendation:</b>	Continue with replacement of the townhouse garage doors over the next three years. We have included a cost allowance for this work in the table.

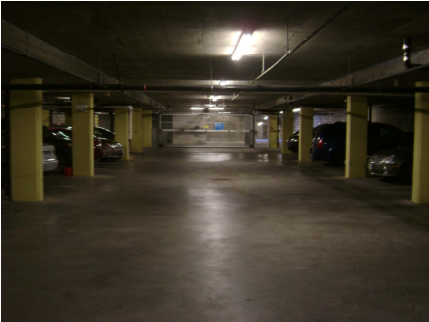
<b>Item:</b>	<b>Encl 18</b>
	<b>Description:</b>	Underground Parking Garage (waterproofing membrane)
	<b>Location:</b>	Buildings '60, '70 & '80
	<b>Current Age:</b>	26 years
	<b>Service Life:</b>	35 years
<b>Assessment:</b>	<p>Buildings '60, '70 &amp; '80 each have a single level of underground parking. Building '60 has 97 residential parking stalls and 14 visitor stalls. Building '70 has 49 residential parking stalls and 7 visitor stalls. Building '80 has 111 residential parking stalls and 13 visitor stalls.</p> <p>According to the drawings, the parking garage ceiling slab extends past the building footprint on all elevations. These areas are covered with concrete topping/pavers (patios), concrete topped sidewalks and landscaping.</p>

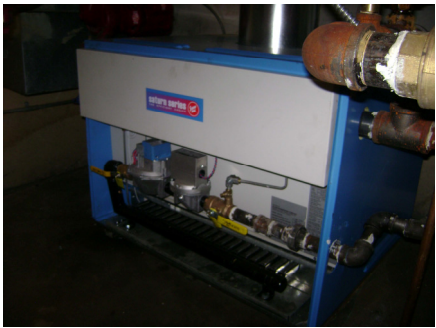
<b>Item:</b>	<b>Mech 2</b>
	<b>Description:</b>	Heating – Gas Boiler (Super Hot or Teledyne Laars)
	<b>Location:</b>	Buildings '60, '70, '80 & '88 – Mechanical room (2 in each building = 8 in total)  TH – Owner's responsibility
	<b>Current Age:</b>	26 years

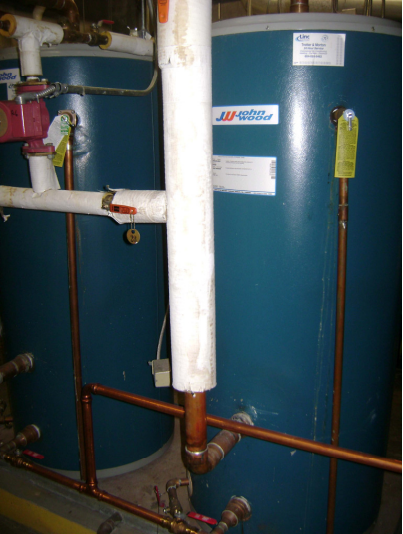
<b>Item:</b>	<b>Mech 3</b>
	<b>Description:</b>	Commercial Storage Tanks (AO Smith, John Wood or Rheem Ruud)
	<b>Location:</b>	Buildings '60, '70 & '88 – Mechanical room (1 at Building '88, 2 each at Buildings '60 & '70 = 5 in total)
	<b>Current Age:</b>	Building '60 – 4 years (2017) Building '70 – 15+ years Building '88 – 6 years (2015)
	<b>Service Life:</b>	Up to 15 years (with routine maintenance)

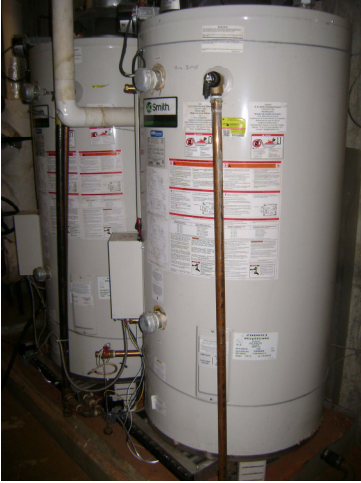
<b>Item:</b>	<b>Mech 4</b>
	<b>Description:</b>	Heating – Natural gas commercial water heater (A.O. Smith) - 2 in total
	<b>Location:</b>	Building '80 - Mechanical
	<b>Current Age:</b>	1 year (2020) 7 years (2014)
	<b>Service Life:</b>	Up to 10 years (with routine maintenance)

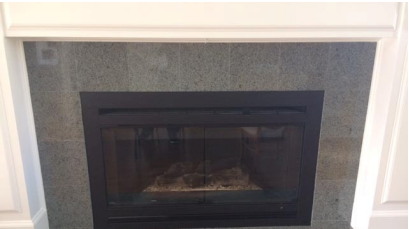
<b>Item:</b>	<b>Mech 5</b>
	<b>Description:</b>	Fireplaces - Gas
	<b>Location:</b>	Building '88 (Strata's responsibility) Buildings '60, '70, '80 & TH

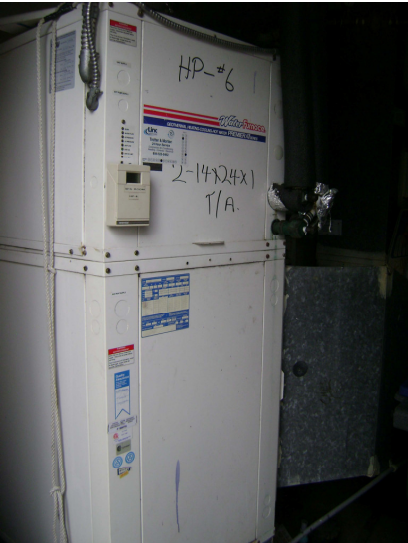
<b>Item:</b>	<b>Mech 6</b>
	<b>Description:</b>	Heat Pumps (6 in total)
	<b>Location:</b>	Building '88 – Above kitchen, above bathroom, mechanical room closets (upper mezzanine and roof), HVAC room
	<b>Current Age:</b>	26 years – Water Furnace (1) 0 years (2021) – York or Fujitsu (5)
	<b>Service Life:</b>	20 years (with routine maintenance)
<b>Assessment:</b>	<p>These units provide heating and cooling to the common areas/rooms of the Clubhouse including the spa room. No problems were noted or reported.</p>	
<b>Recommendation:</b>	<p>These units should be inspected regularly (every three months) and maintained, as part of the service contract. Cost for future replacement has been included.</p>

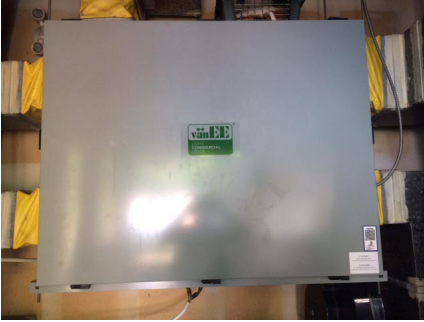
<b>Item:</b>	<b>Mech 8</b>
	<b>Description:</b>	Heat Recovery Unit (HRU - Vaneec)
	<b>Location:</b>	Building '88 - HVAC room
	<b>Current Age:</b>	0 years (2021)
	<b>Service Life:</b>	25 years (with routine maintenance)
<b>Assessment:</b>	This unit provides air exchange for the spa room and change rooms of the Clubhouse. No problems were noted or reported.	
<b>Recommendation:</b>	This unit should be inspected regularly (at least semi-annually) and maintained, as part of the service contract. Cost for future replacement has been included, based on expected service life.

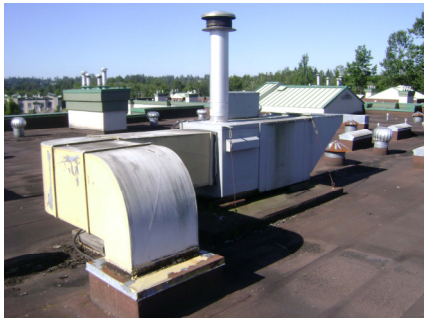
<b>Item:</b>	<b>Mech 9</b>
	<b>Description:</b>	Make-up Air Units – Engineered Air (natural gas) – 5 in total
	<b>Location:</b>	Building '60 - Main flat roof (2 units) Building '70 – Main flat roof Building '80 – Main flat roof (2 units)

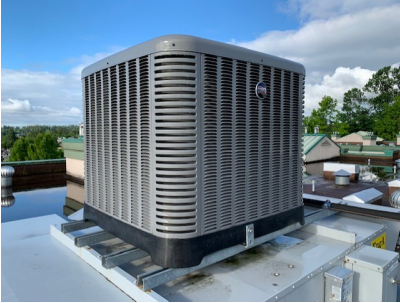
<b>Item:</b>	<b>Mech 10</b>
	<b>Description:</b>	A/C Units – Rheem (5 in total)
	<b>Location:</b>	Building '60 - Main flat roof (2 units) Building '70 – Main flat roof Building '80 – Main flat roof (2 units)
	<b>Current Age:</b>	2 years (2019)
	<b>Service Life:</b>	25 years (with routine maintenance)
<b>Assessment:</b>	These rooftop units provide cooling to the common areas of the apartment buildings. No problems were noted or reported.	
<b>Recommendation:</b>	These units should be inspected regularly and maintained, as part of the service contract. Cost for future replacement has been included.

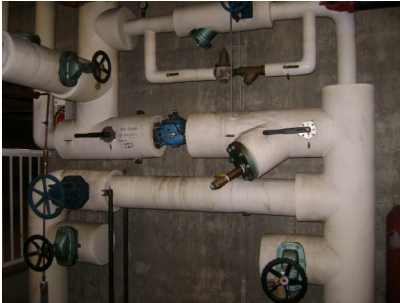
<b>Item:</b>	<b>Mech 11</b>
	<b>Description:</b>	PRV System
	<b>Location:</b>	Buildings '60, '70 & '80 - Underground parkade
	<b>Current Age:</b>	26 years
	<b>Service Life:</b>	Varies (replacement of components)
<b>Assessment:</b>	This system reduces the city water pressure coming into the building. No problems were noted or reported. Inspection and

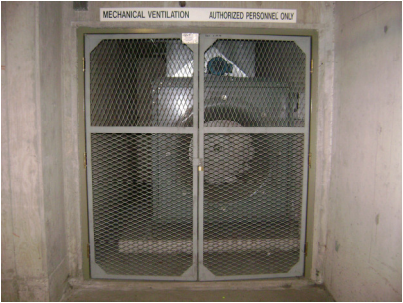
<b>Item:</b>	<b>Mech 12</b>
	<b>Description:</b>	Parkade Exhaust Fans
	<b>Location:</b>	Building '60 – Underground parkade (2 units) Building '70 – Underground parkade Building '80 - Underground parkade (2 units)
	<b>Current Age:</b>	26 years
	<b>Service Life:</b>	Varies (replacement of components)

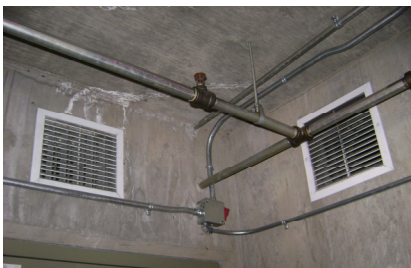
<b>Item:</b>	<b>Mech 13</b>
	<b>Description:</b>	Ventilation Fans
	<b>Location:</b>	Buildings '60, '70, '80 & '88 - Underground parkade service/locker rooms & Clubhouse service rooms

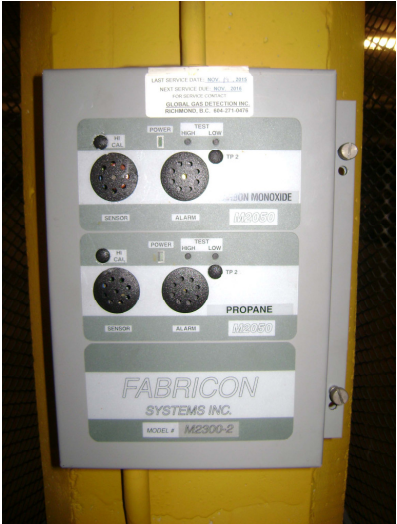
<b>Item:</b>	<b>Mech 14</b>
	<b>Description:</b>	Gas Detection System (Carbon Monoxide)
	<b>Location:</b>	Buildings '60, '70 & '80 - Underground parkade
	<b>Current Age:</b>	N/A
	<b>Service Life:</b>	10 years
<b>Assessment:</b>	The gas detection system consists of control panels, c/w carbon monoxide sensors and propane sensors throughout the parkade. Inspection and testing of the gas detection system is typically conducted on an annual basis, the last one being in July 2020 by Global Gas Detection Inc. Some minor deficiencies were noted in their latest inspection report. The next test/inspection date is scheduled for July 2021.	
<b>Recommendation:</b>	Testing/inspection should be ongoing regularly (at least annually) and repairs/replacement completed as required and recommended in the annual inspection reports. The sensors, typically, have a lifespan of approx. 6-10 years and will require replacement from time to time, as will some of the electronic components inside the control panel. We have included a replacement cost allowance in the table.

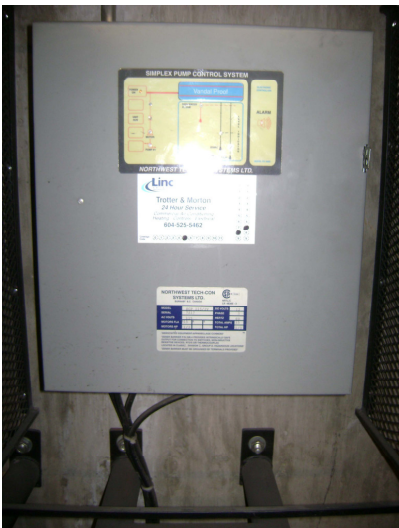
<b>Item:</b>	<b>Mech 15</b>
	<b>Description:</b>	Sump Pump
	<b>Location:</b>	Building '80 - Underground parkade
	<b>Current Age:</b>	26 years
	<b>Service Life:</b>	25 years
<b>Assessment:</b>	<p>There is one storm sump pump in the underground parkade of The Windsor, connected to a control panel. The pump was not visible for review. There was no access to the pump, however, no problems were reported. It is not known how often these pumps currently get checked/serviced.</p>	
<b>Recommendation:</b>	<p>The pump and panel should be inspected at least semi-annually and maintained as part of the service contract (operating budget). Future cost to replace the pump has been included in the table, although the pump most likely gets limited use.</p>

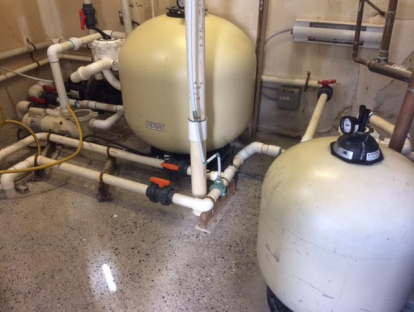
<b>Item:</b>	<b>Mech 17</b>
	<b>Description:</b>	Pool/Spa Equipment (sand filters, spa jet pump, spa & pool heat exchanger)
	<b>Location:</b>	Building '88 – Pool mechanical room
	<b>Current Age:</b>	Varies
	<b>Service Life:</b>	N/A
<b>Assessment:</b>	Various pond equipment in the pool mechanical room consists of pumps (eg.jet pump), sand filters and pool/spa heat exchangers. Repairs/replacement to various components are being completed, on an as-needed basis. No problems were noted or reported.	
<b>Recommendation:</b>	Testing/inspection should be completed on a regular basis (at least semi-annually) and maintained. We have included a contingency allowance for ongoing future replacement of components.

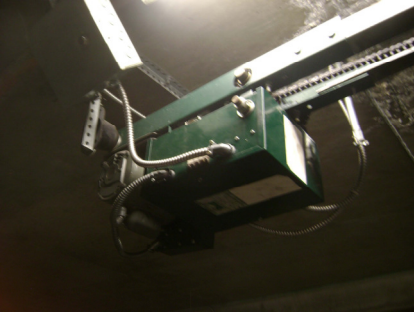
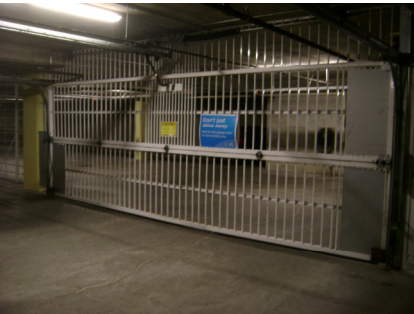
<b>Item:</b>	<b>Mech 18</b>
	<b>Description:</b>	Overhead Door Operators & Gate –  Building '60 & '80 – Chamberlain Liftmaster Elite – 2 in total  Building '60 & '70 – Manaris MTBHS, 1/2HP – 3 in total
	<b>Location:</b>	Buildings '60, '70 &, '80 - Underground Parkade - Exterior overhead gate
	<b>Current Age:</b>	26 years
	<b>Service Life:</b>	Overhead Door Operator - 15 years Overhead Gate – N/A
<b>Assessment:</b>	There are two gates/operators in the underground of Buildings '60 & 70 and one gate/operator in the underground of Building '80. The gate operators were reported to be original. No problems were reported. The operators and gates are being serviced quarterly and/or on an as-needed basis.	
<b>Recommendation:</b>	The gates, operators and all related components should continue to

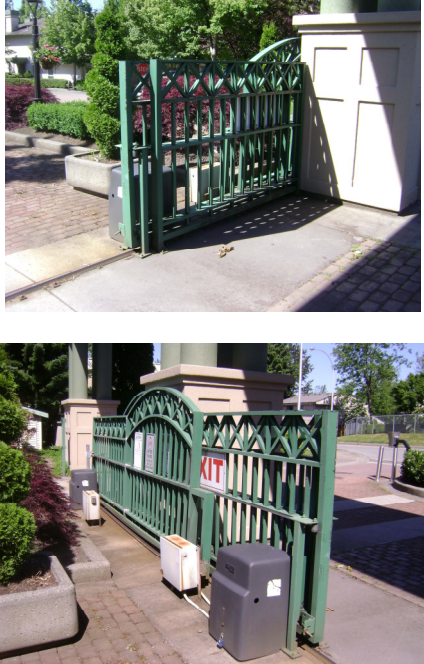
<b>Item:</b>	<b>Mech 19</b>
	<b>Description:</b>	Security Slide/Swing Gates & Slide Gate Operators
	<b>Location:</b>	North and east entrances of complex
	<b>Current Age:</b>	Gate – 26 years Operator - 26 years
	<b>Service Life:</b>	Gate – N/A Operator – N/A
<b>Assessment:</b>	Security gates and operators are located at the north and east entrances of the complex. No problems were reported.	
<b>Recommendation:</b>	The gates, operators and all related components are being checked regularly and maintained, as required, including painting. Components should be replaced as required (operating budget) to extend the life of the components. No replacement cost has been included.

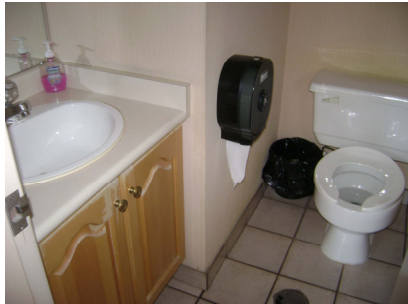
<b>Item:</b>	<b>Mech 20</b>
	<b>Description:</b>	Plumbing fixtures (toilets, urinals sinks, faucets, dishwasher, showers)
	<b>Location:</b>	Building '88 – Guest Rooms, Manager Suite, Kitchen, Bar, Bathrooms, Change Rooms
	<b>Current Age:</b>	Varies

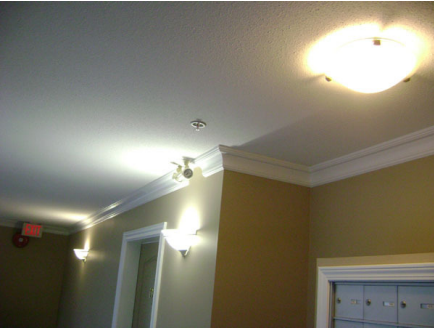
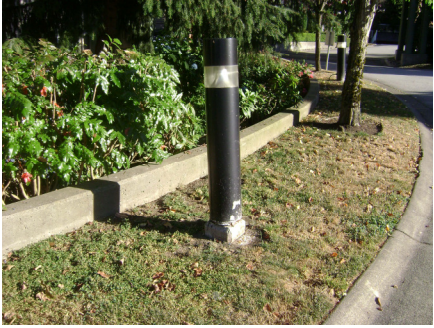
<b>Item:</b>	<b>Elec 2</b>
	<b>Description:</b>	Common Lighting
	<b>Location:</b>	Buildings '60, '70, '80, '88 & TH) - Common areas (Interior - hallways, stairwells, lobby, parking garage, common rooms and Exterior – front entrances, building perimeters, light posts/bollards, parkade ramp)
	<b>Current Age:</b>	Varies
	<b>Service Life:</b>	25 years
<b>Assessment:</b>	No problems were reported with the common area lighting. It was reported that the light fixtures have been upgraded/retrofitted with LED lighting over the years.	
<b>Recommendation:</b>	We have included a future allowance in the table for future lighting upgrade/replacement in the complex.

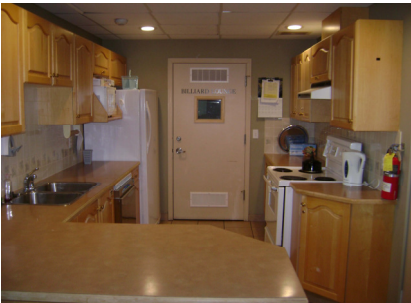
<b>Item:</b>	<b>Elec 3</b>
	<b>Description:</b>	Electrical appliances (dishwasher, range/stove, refrigerator, ice machine, microwave)
	<b>Location:</b>	Building '88 – Kitchen, Bar, Manager Suite

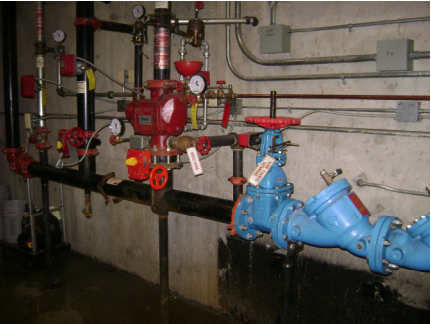
<b>Item:</b>	<b>Fire 1</b>
	<b>Description:</b>	Fire Suppression System
	<b>Location:</b>	Buildings '60, '70, '80 - Sprinkler/Mechanical room in underground parkade
	<b>Current Age:</b>	26 years
	<b>Service Life:</b>	Indefinite
<b>Assessment:</b>	<p>The interior of all units are sprinklered, except for Building '88. Inspection and testing of the fire suppression system is typically conducted on an annual basis, the last one being in July 2020 by City Fire Prevention Services. Minor deficiencies were observed reported in the latest inspection report. The next test/inspection date is scheduled for July 2021.</p>	
<b>Recommendation:</b>	<p>Testing/inspection should be completed on a regular basis (at least annually), and repairs/replacement, as required and recommended in the annual inspection reports if required. A contingency allowance for minor repairs/replacement has been included for in the table.</p>

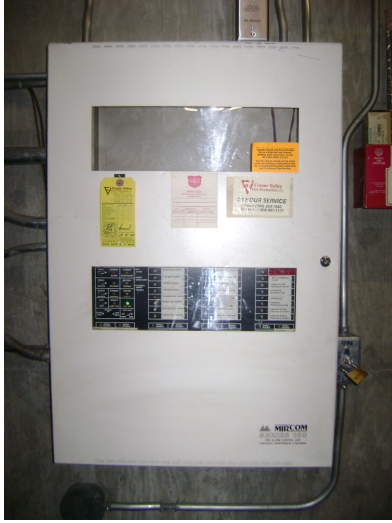
<b>Item:</b>	<b>Fire 2</b>
	<b>Description:</b>	Fire Alarm System (Alarm panel & Annunciator panel)
	<b>Location:</b>	Buildings '60, '70, '80 & '88  Fire Alarm Panels – Sprinkler room in underground parkade or electrical closet ('88)  Annunciator Panel - Lobby
	<b>Current Age:</b>	Buildings '60, '70 & '80 – 26 years  Buildings '88 - 5 years (2016)

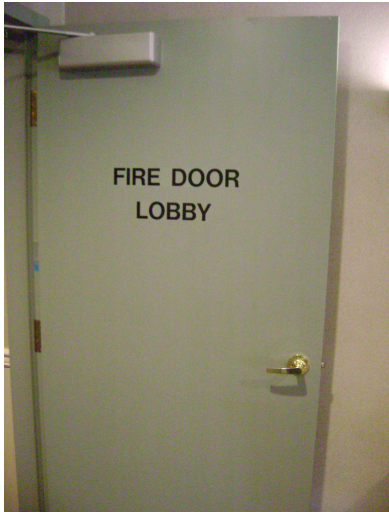
<b>Item:</b>	<b>Fire 3</b>
	<b>Description:</b>	Fire Doors
	<b>Location:</b>	Buildings '60,'70,'80,'88 – interior hallways and stairwells
	<b>Current Age:</b>	26 years
	<b>Service Life:</b>	N/A
<b>Assessment:</b>	<p>The fire doors appeared to be in acceptable condition with no major deficiencies observed or reported.</p>

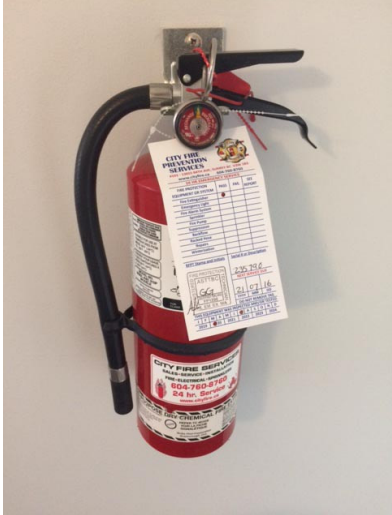
<b>Item:</b>	<b>Fire 4</b>
	<b>Description:</b>	Portable Fire Extinguishers
	<b>Location:</b>	Buildings '60,'70,'80,'88 – interior hallways and parkade
	<b>Current Age:</b>	Varies
	<b>Service Life:</b>	6 years

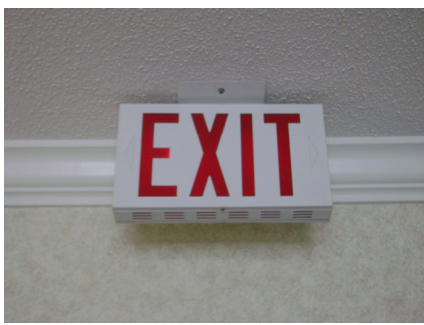
<b>Item:</b>	<b>Fire 5</b>
	<b>Description:</b>	Emergency Lighting
	<b>Location:</b>	Buildings '60,'70,'80,'88 – interior hallways, stairwells and parkade
	<b>Current Age:</b>	N/A
	<b>Service Life:</b>	N/A
