REPORT
DEPRECIATION SERVICES

Chelsea Gardens - Strata Plan LMS 1416
13860 – 13888 70th Avenue, Surrey, BC

Date: March 4, 2026
Project Number: VR24565

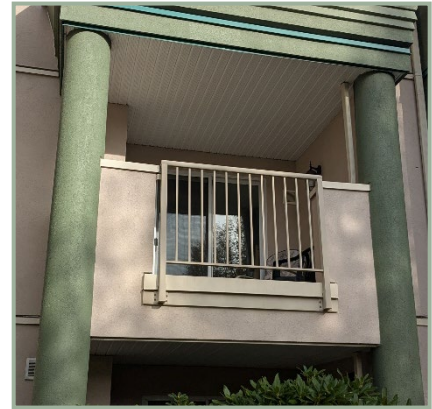
2 BALCONY GUARDRAILS (CONDOS)		
BUILDING ENVELOPE AND STRUCTURE	Location:	Perimeter edges of balconies on all the condo buildings
	Year Installed:	2007
	Typical Service Life (years):	40
	Effective Age (years):	18
	Remaining Service Life (years):	22
	Planned Renewal Date:	2047
	<p>Description: This item includes all the side mounted aluminum picket and post guardrails installed along the perimeter edges of the balconies on all the condo buildings. This does not include the spindle guardrails on the decks of the townhouses.</p> <p>Condition: It was noted that these guardrails were installed during the envelope remediation project in 2007. The guardrails are in fair condition with no visual indication of corrosion or loose attachments. Additionally, no issues were reported by the residents or the strata president.</p> <p>Comments: The reserve costs include replacing all the aluminum guardrails on the balconies.</p>

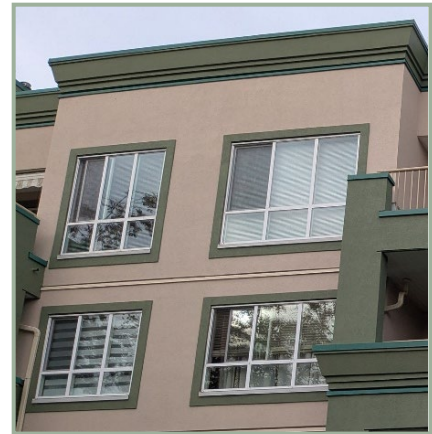
10 WINDOW ASSEMBLIES (CONDOS)	
BUILDING ENVELOPE AND STRUCTURE	Location: Building exterior of condos
	Year Installed: 2007
	Typical Service Life (years): 30
	Effective Age (years): 18
	Remaining Service Life (years): 12
	Planned Renewal Date: 2037
	<p>Description: This item includes all the windows installed on the Mayfair, Kensington and Windsor condo buildings and the Clubhouse building.</p> <p>Condition: The windows are in reasonable condition with no observations or reports of deficiencies. It was noted that these windows were replaced during the envelope remediation project in 2007.</p> <p>Comments: The reserve costs include the full renewal of the windows on the condo buildings.</p>

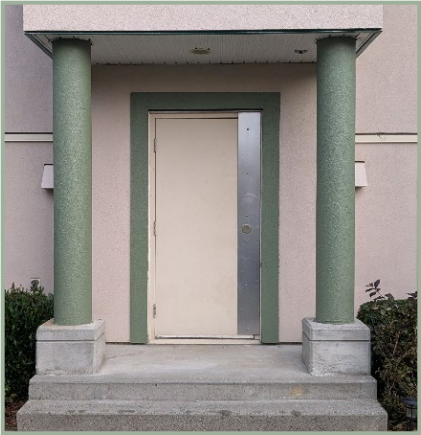
16 SERVICE DOORS			
BUILDING ENVELOPE AND STRUCTURE	Location:	Throughout property

Year Installed:	1995	
	Typical Service Life (years):	50	
	Effective Age (years):	30	
	Remaining Service Life (years):	20	
	Planned Renewal Date:	2045	
	<p>Description: This item includes the doors used to access all the utility rooms around the property and in the parkades. This also includes the doors used to access the exit stairways in the condos, and the exit doors in the Clubhouse building.</p> <p>Condition: The service doors are in operable condition with no observations or reports of deficiencies.</p> <p>Comments: Since these service doors typically don't see much traffic, they can be expected to last longer compared to other doors. The reserve costs include partially replacing some of the service doors.</p>

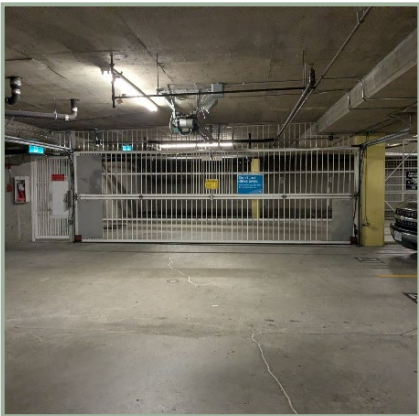
17 GARAGE GATES (CONDOS)			
BUILDING ENVELOPE AND STRUCTURE	Location:	Parkades interior

Year Installed:	1995	
	Typical Service Life (years):	30	
	Effective Age (years):	20	
	Remaining Service Life (years):	10	
	Planned Renewal Date:	2035	
	<p>Description: This item includes all the metal grate overhead garage gates inside the parkades.</p> <p>Condition: These gates are in operable condition with no reports of deficiencies.</p> <p>Comments: The reserve costs include replacing these garage gates in the parkades. Allowances have been made to replace the gate motors.</p>

- Consider replacing some of the building envelope items depending on the findings made during the BECA (items #3, 5, 6, 9, 11, 13, 14, 15, 21, 27 and 28).
- Replace the parkade garage door motors (item #17).

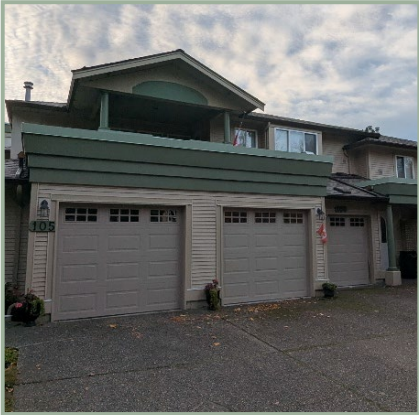
18 GARAGE DOORS (TOWNHOUSES)			
BUILDING ENVELOPE AND STRUCTURE	Location:	Front entry of townhouses

Year Installed:	2020	
	Typical Service Life (years):	30	
	Effective Age (years):	5	
	Remaining Service Life (years):	25	
	Planned Renewal Date:	2050	
	<p>Description: This item includes all the overhead garage doors on the townhouses. This does not include the motors in the garages, as these are assumed to be the owner's responsibility.</p> <p>Condition: The garage doors are in operable condition with no reports of deficiencies. It was noted that all the townhouse garage doors have been replaced in phases since 2016. We have set the installation date to the conservative average of 2020.</p> <p>Comments: The reserve costs include fully replacing all the garage doors.</p>

- As planned, replace some of the townhouse garage doors for the next three years (item #18).
- As planned, replace the low-slope roof membrane above all the condo buildings for the next three years (item #23).

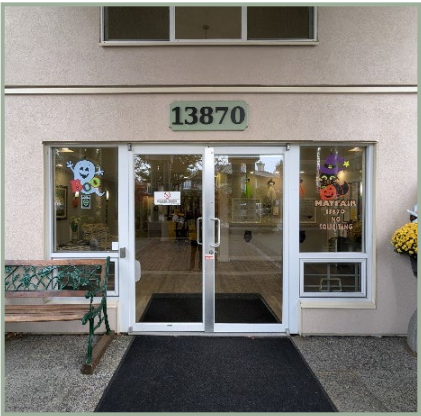
19 FRONT ENTRANCE (CONDOS)			
BUILDING ENVELOPE AND STRUCTURE	Location:	Entrance of condos

Year Installed:	2007	
	Typical Service Life (years):	30	
	Effective Age (years):	18	
	Remaining Service Life (years):	12	
	Planned Renewal Date:	2037	
	<p>Description: This item includes all the doors, windows and the glazing system at the front entrances of the Kensington, Mayfair, Windsor condo buildings and the Clubhouse building.</p> <p>Condition: These entrance systems are in fair condition with no observations of cracks or water ingress in the glazing units or any reports of problems in their operation. It was noted that the front entry doors and windows for the condos were renewed during the envelope remediation project in 2007.</p> <p>Comments: The reserve cost includes an allowance for targeted repairs and potential IGU replacements.</p>

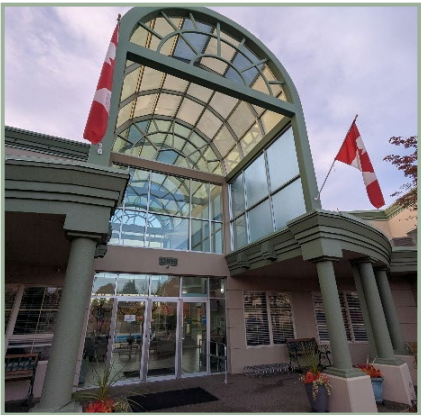
20 FRONT ENTRANCE & GLASS CANOPY (CLUBHOUSE)			
BUILDING ENVELOPE AND STRUCTURE	Location:	Entrance of Clubhouse building

Year Installed:	2023	
	Typical Service Life (years):	30	
	Effective Age (years):	2	
	Remaining Service Life (years):	28	
	Planned Renewal Date:	2053	
	<p>Description: This item includes the front entrance system and the glass canopy installed over the front entry and the lobby of the Clubhouse building.</p> <p>Condition: The front entrance and glass canopy appear to be in fair condition with no cracks on the window panels or corrosion on the frames. The strata manager informed that the glass canopies and their associated glazing system were renewed in 2023.</p> <p>Comments: The reserve cost includes an allowance for targeted repairs and potential IGU replacements.</p>

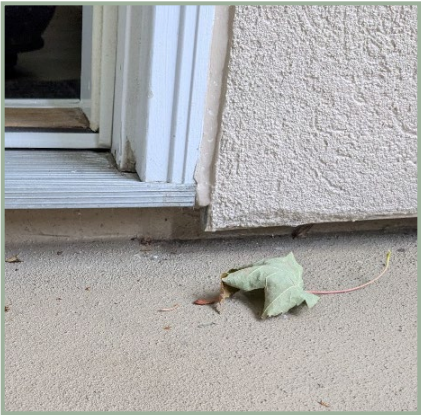
21	SEALANT

BUILDING ENVELOPE AND STRUCTURE	Location:	Building exterior	
	Year Installed:	1995	
	Typical Service Life (years):	10	
	Effective Age (years):	0	
	Remaining Service Life (years):	10	
	Planned Renewal Date:	2035	
	<p>Description: This item includes the sealants installed throughout the building envelope of the buildings.</p> <p>Condition: Where installed, the sealant around windows appeared to be in fair to poor condition. It is our understanding that building envelope repairs have been performed as a maintenance item every year for the townhouses. Due to this, some areas appeared to be in much poorer condition compared to others. The observable sealants on the condo buildings were in reasonable condition.</p> <p>Comments: The reserve costs include an allowance for targeted repairs of the sealant installed on the building envelope system throughout the property. An allowance has been projected in 2030 to replace any sealants in poor condition. The service life has been set to time with exterior paint coating (item #22) so that these two assets can be renewed together and reduce mobilization costs. This item should be included in the BECA mentioned in item #6 to better determine its remaining service life and the scope of renewal work.</p>

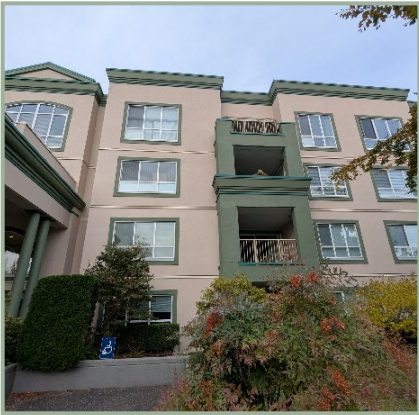
22	PAINT COATING

BUILDING ENVELOPE AND STRUCTURE	Location:	Building exterior surfaces	
	Year Installed:	2025	
	Typical Service Life (years):	10	
	Effective Age (years):	0	
	Remaining Service Life (years):	10	
	Planned Renewal Date:	2035	
	<p>Description: This item includes all the paint applied to the exterior wall surfaces throughout the property.</p> <p>Condition: The paint on the exterior walls appears to be in fair condition. It was informed by the strata manager that paint renewals have been performed on the townhouses, condos, perimeter fencing and all outbuilding structures (gates, entrances, electrical rooms).</p> <p>Comments: The reserve cost includes repainting the painted exterior surfaces of all buildings and structures. It is recommended to conduct this in conjunction with the sealant repairs (item #21) to save on mobilization costs. The cost for the repainting project has been deducted from the CRF balance in the projections to more accurately represent the strata council's financials.</p>

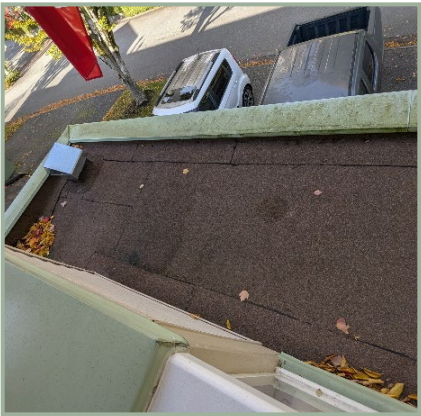
24 LOW SLOPE ROOF – SBS (TOWNHOUSES)

BUILDING ENVELOPE AND STRUCTURE	Location:		Above the townhouses and Clubhouse building
	Year Installed:		2021
	Typical Service Life (years):		25
	Effective Age (years):		4
	Remaining Service Life (years):		21
	Planned Renewal Date:		2046
<p>Description: This item includes all the SBS torch-on low-slope roofing on the townhouses. This also includes the metal flashing around the roof edges.</p> <p>Condition: The low-slope roofs are in reasonable condition with no reports of deficiencies. It was noted that all the low sloped roofing for the townhouses, and half of the low sloped roofing for the clubhouse building were replaced from 2021 to 2025.</p> <p>Comments: The reserve cost includes full renewal of the low-slope roofs for the townhouses and the clubhouse building. An allowance has been made in 2030 to replace the other half of the low sloped roofing for the clubhouse building.</p>

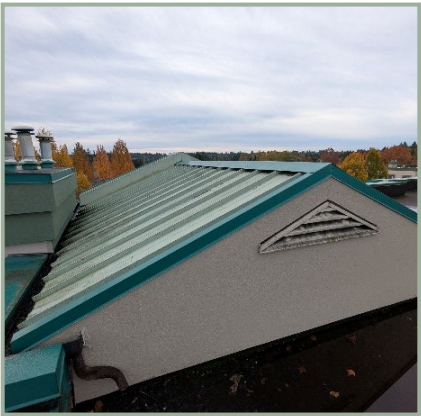
25 STEEP SLOPE ROOF – METAL

BUILDING ENVELOPE AND STRUCTURE	Location:		Above the condos and Clubhouse building
	Year Installed:		1995
	Typical Service Life (years):		40
	Effective Age (years):		30
	Remaining Service Life (years):		10
	Planned Renewal Date:		2035
	<p>Description: This item includes the corrugated metal roof panels installed on top of the Kensington, Mayfair and Windsor condo buildings and the Clubhouse building.</p> <p>Condition: The metal roof panels are in average condition. Minor corrosion and debris accumulation were observed throughout all these roofs.</p> <p>Comments: The reserve cost includes fully replacing the metal roof panels. This item should be included in the BECA mentioned in item #6 to better determine its remaining service life.</p>

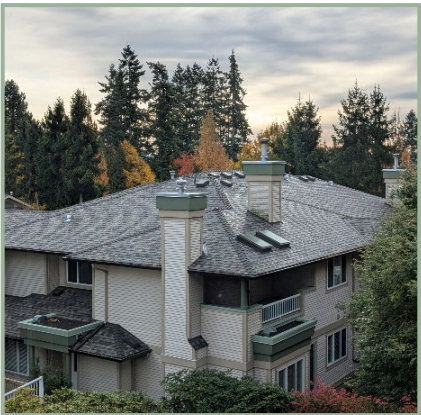
26 STEEP SLOPE ROOF – ASPHALTIC SHINGLES

BUILDING ENVELOPE AND STRUCTURE	Location:		Above the townhouses
	Year Installed:		2021
	Typical Service Life (years):		25
	Effective Age (years):		4
	Remaining Service Life (years):		21
	Planned Renewal Date:		2046
	<p>Description: This item includes the asphaltic roof shingles installed on all the roofs of the townhouses.</p> <p>Condition: The asphaltic roof shingles are in fair condition. It was noted that these roofs were replaced during the roof replacement project that occurred between 2021 and 2025.</p> <p>Comments: The reserve cost includes fully replacing the asphaltic shingles in the planned renewal year.</p>

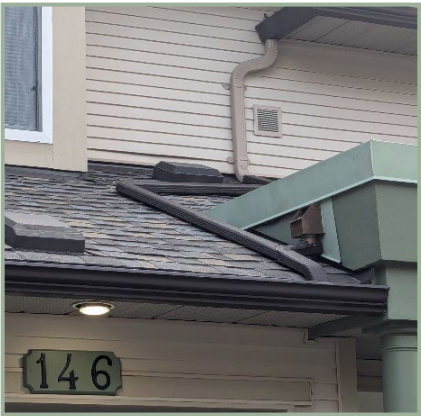
27 GUTTERS & DOWNSPOUTS			
BUILDING ENVELOPE AND STRUCTURE	Location:	Perimeter of roofs and along exterior walls

Year Installed:	2021	
	Typical Service Life (years):	15	
	Effective Age (years):	4	
	Remaining Service Life (years):	11	
	Planned Renewal Date:	2036	
	<p>Description: This item includes gutters and downspouts installed along the perimeters of the roofs and along the exterior walls of the townhouses.</p> <p>Condition: The gutters and downspouts appear to be in serviceable condition with no reports or observations of deficiencies. It was noted that the gutters and downspouts were replaced with the townhouse roof replacements from 2021 to 2025.</p> <p>Comments: The reserve cost includes renewing the gutters and downspouts on roofs.</p>

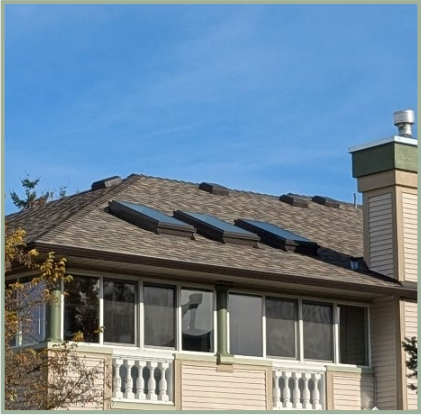
28 SKYLIGHTS			
BUILDING ENVELOPE AND STRUCTURE	Location:	On townhouse roofs

Year Installed:	2021	
	Typical Service Life (years):	35	
	Effective Age (years):	4	
	Remaining Service Life (years):	31	
	Planned Renewal Date:	2056	
	<p>Description: This item includes all the skylight panels installed on the roofs of the townhouses</p> <p>Condition: The townhouses appear to be in reasonable condition. No problems or issues with the skylights were reported. It was noted that these skylights were replaced with the townhouse roof replacements from 2021 to 2025.</p> <p>Comments: The reserve cost includes an allowance for targeted repairs and partial replacements.</p>

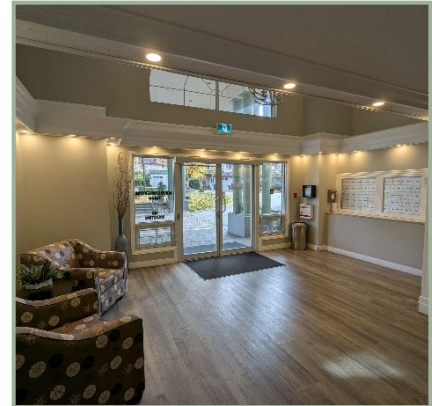
30 LOBBIES		
INTERIOR	Location:	Entrance of condos and Clubhouse building
	Year Installed:	2017
	Typical Service Life (years):	20
	Effective Age (years):	8
	Remaining Service Life (years):	12
	Planned Renewal Date:	2037
<p>Description: This item includes all the lobbies in the Kensington, Mayfair and Windsor condo buildings and the Clubhouse building. This includes the lobby finish and the décor.</p> <p>Condition: The lobbies appeared to be in fair condition. It was noted that the lobbies for these buildings have been being replaced from 2017 to 2021.</p> <p>Comments: The reserve costs include an allowance for targeted repairs or replacements of all the lobbies in these buildings. Due to the aesthetic nature of this asset, the renewal cost, date and scope are at discretion of the owners.</p>

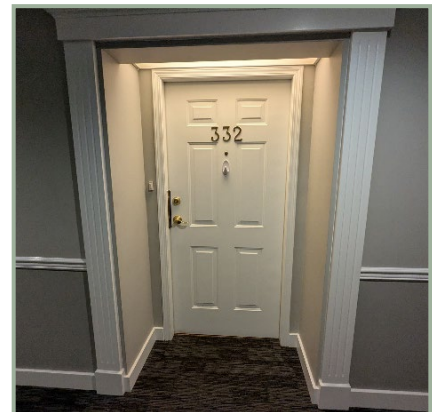
31 UNIT ENTRY DOORS & INTERIOR DOORS		
INTERIOR	Location:	Buildings interior
	Year Installed:	1995
	Typical Service Life (years):	50
	Effective Age (years):	30
	Remaining Service Life (years):	20
	Planned Renewal Date:	2045
<p>Description: This item includes all the wood core unit entry doors in the condo buildings and the interior wood core doors in the Clubhouse building.</p> <p>Condition: The unit entry doors are in fair condition. No reports or observations were made of any problems with their operation.</p> <p>Comments: The reserve costs include fully replacing the doors. Since the doors are in an indoor condition, these doors are expected to last much longer. Therefore, only half of the reserve cost has been allotted for targeted replacement in the planned renewal year.</p>

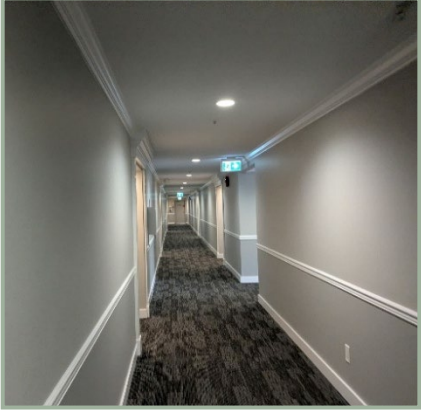
32 HALLWAYS & STAIRWELLS (CONDOS)			
INTERIOR	Location:	Buildings interior

Year Installed:	2017	
	Typical Service Life (years):	15	
	Effective Age (years):	7	
	Remaining Service Life (years):	8	
	Planned Renewal Date:	2033	
<p>Description: This item includes all the drywall finishes on the walls and the ceiling, and the carpets in the hallways found in the three condo buildings. This also includes the finishes inside the stairwells.</p> <p>Condition: The hallway finishes appear to be in fair condition with no observations or reports of deficiencies. It was noted that these finishes were renewed in phases from 2017 to 2021 for all the condo buildings.</p> <p>Comments: The reserve costs include fully replacing the finishes in the hallways and stairwells in all the condo buildings. Only half of the stairwell finishes were included as these areas usually do not see much traffic and deterioration. This item's service life has been set to time with the paint coating renewals of the condo hallways (item #34). Due to the aesthetic nature of this asset, the renewal cost, date and scope are at discretion of the owners.</p>

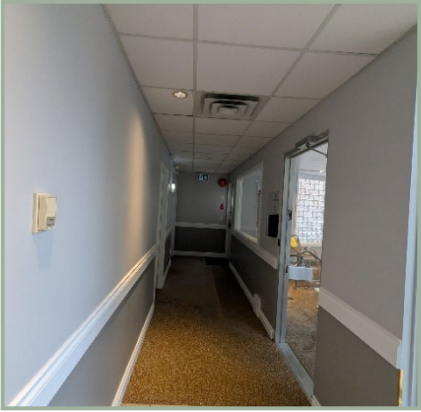
33 HALLWAYS & STAIRWELLS (CLUBHOUSE)			
INTERIOR	Location:	Clubhouse building interior

Year Installed:	1995	
	Typical Service Life (years):	15	
	Effective Age (years):	4	
	Remaining Service Life (years):	11	
	Planned Renewal Date:	2036	
<p>Description: This item includes all the hallway and stairwell finishes in the Clubhouse. This includes the drywall, ceiling tiles and the flooring.</p> <p>Condition: The hallway finishes in the clubhouse building appears to be in fair condition. It was noted that some of the floor finishes were renewed during the Clubhouse Improvement project in 2017.</p> <p>Comments: The reserve costs include fully replacing the finishes in the hallways and stairwells of the Clubhouse building. This item's service life has been set to time with the paint coating renewal of the Clubhouse (item #35). Due to the aesthetic nature of this asset, the renewal cost, date and scope are at discretion of the owners.</p>

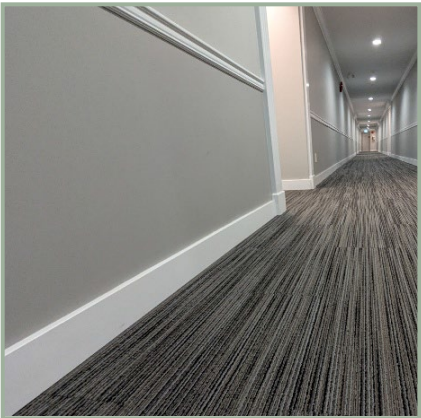
34 PAINT COATING – INTERIOR (CONDOS)			
INTERIOR	Location:	Condo building interior

Year Installed:	2018	
	Typical Service Life (years):	15	
	Effective Age (years):	7	
	Remaining Service Life (years):	8	
	Planned Renewal Date:	2033	
<p>Description: This item includes all the painted finish in the interior of all the condo buildings.</p> <p>Condition: The paint appears to be in fair condition with no observable damage or stains. It was noted that all the finishes in the condo buildings were repainted from 2018 to 2021.</p> <p>Comments: The reserve costs include fully repainting the interior finishes in the three condo buildings. Due to the aesthetic nature of this asset, the renewal cost, date and scope are at discretion of the owners.</p>

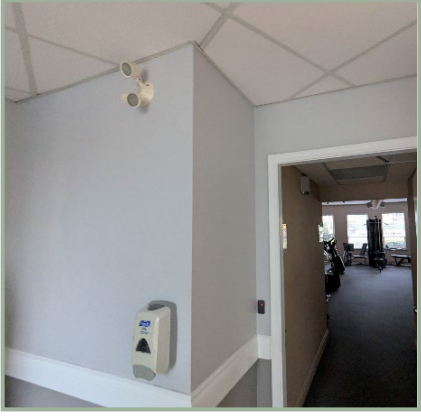
35 PAINT COATING – INTERIOR (CLUBHOUSE)			
INTERIOR	Location:	Clubhouse building interior

Year Installed:	2021	
	Typical Service Life (years):	15	
	Effective Age (years):	4	
	Remaining Service Life (years):	11	
	Planned Renewal Date:	2036	
<p>Description: This item includes all the painted finish in the Clubhouse building. This includes all the painted finish in the amenity rooms like the gym, library, lounge, etc.</p> <p>Condition: The interior painted finish appears to be in fair condition. It was noted that these finishes were repainted in 2021.</p> <p>Comments: The reserve costs include fully repainting the interior surfaces. Due to the aesthetic nature of this asset, the renewal cost, date and scope are at discretion of the owners.</p>

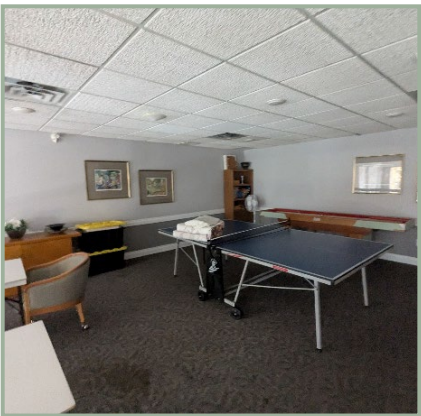
36 AMENITY ROOM FINISHES	
INTERIOR	Location: Clubhouse building interior
	Year Installed: 1995
	Typical Service Life (years): 20
	Effective Age (years): 9
	Remaining Service Life (years): 11
	Planned Renewal Date: 2036

<p>Description: This item includes all the room finishes for the many amenity rooms inside the Clubhouse building.</p> <p>Condition: The interior finishes of amenity rooms appear to be in reasonable condition with no observable deficiencies.</p> <p>Comments: The reserve costs include an allowance for renewing the interior surfaces. The service life for this item has been set to be replaced in conjunction with the hallways and stairwells renewal project for item #33. Due to the aesthetic nature of this asset, the renewal cost, date and scope are at discretion of the owners.</p>

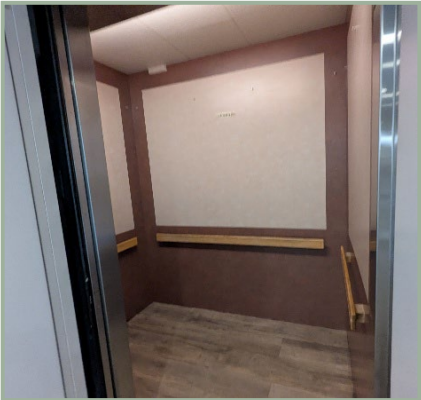
38 ELEVATOR CAB FINISHES	
CONVEYANCE	Location: Elevator interior
	Year Installed: 1995
	Typical Service Life (years): 15
	Effective Age (years): 10
	Remaining Service Life (years): 5
	Planned Renewal Date: 2030

Description: This item includes the cab finish inside the elevator cabs.	
Condition: The cab finishes are in reasonable condition.	
Comments: The reserve costs include replacing the elevator cab finishes. Since this asset will likely be replaced with the elevators, its service life has been set to time with the planned elevator modernization (item #36).

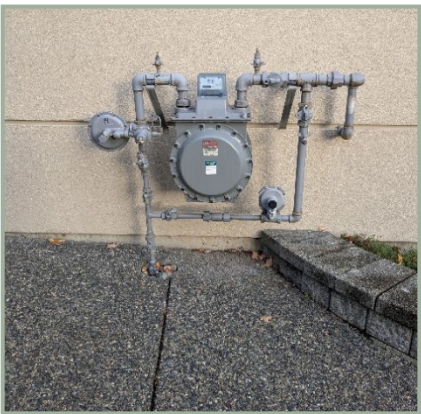
40 GAS PIPES			
MECHANICAL	Location:	Underground throughout property

Year Installed:	1995	
	Typical Service Life (years):	50	
	Effective Age (years):	30	
	Remaining Service Life (years):	20	
	Planned Renewal Date:	2045	
<p>Description: This item includes all the underground gas piping throughout the property.</p> <p>Condition: The gas pipe's condition could not be verified with a non-exploratory visual review. No issues were reported.</p> <p>Comments: The reserve costs include an allowance for potential replacement and targeted repairs of the underground gas pipes.</p>

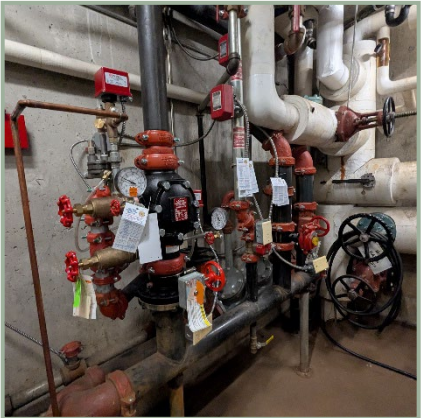
41 SPRINKLER PIPES – FIRE PROTECTION			
MECHANICAL	Location:	Throughout parkades and mechanical rooms

Year Installed:	1995	
	Typical Service Life (years):	50	
	Effective Age (years):	30	
	Remaining Service Life (years):	20	
	Planned Renewal Date:	2045	
<p>Description: This item includes the sprinkler system servicing the two parkades. This also includes the pumping/compressor equipment found in the mechanical rooms in the parkades.</p> <p>Condition: The sprinkler pipes appear to be in reasonable condition. No notable deficiencies were observed or reported.</p> <p>Comments: The fire suppression lines will likely last for a significant period of time. Costs associated with this asset will likely consist of upgrading or repairing mechanical components such as sprinkler heads, pumps, air compressors, etc. An allowance has been included for renewing a percentage of the sprinkler system in the parkade.</p>

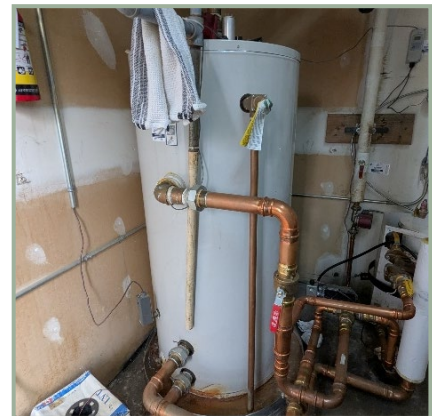
43 HOT WATER STORAGE TANKS	
MECHANICAL	Location: Mechanical rooms
	Year Installed: 2014
	Typical Service Life (years): 15
	Effective Age (years): 11
	Remaining Service Life (years): 4
	Planned Renewal Date: 2029
<p>Description: This item includes the hot water storage tanks found in the mechanical rooms of the condo buildings and the Clubhouse building.</p> <p>Condition: The hot water storage tanks are in operable condition. It was observed from the manufacturing dates of these hot water storage tanks that the tank servicing the clubhouse building was replaced around 2014, Kensington around 2017, Windsor around 2020, and Mayfair around 2021.</p> <p>Comments: The reserve costs include fully replacing the hot water storage tanks. For the first renewal, the cost only includes the replacement of the hot water storage tank servicing the clubhouse building. Other tanks are projected to be renewed in 2031. This item should be included in the condition assessment mentioned in item #42 to better determine its remaining service life.</p>

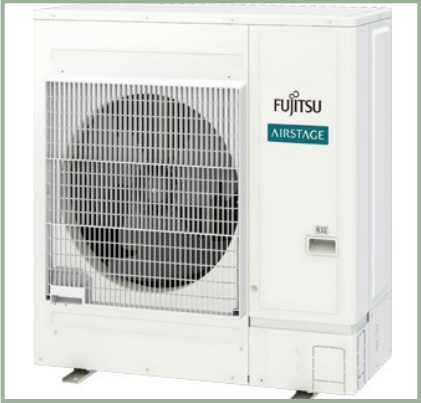
44 HEAT PUMP & AIR CONDITIONING

MECHANICAL	Location:		Throughout Clubhouse building
	Year Installed:		2021
	Typical Service Life (years):		20
	Effective Age (years):		4
	Remaining Service Life (years):		16
	Planned Renewal Date:		2041
<p>Description: This includes the heat pumps servicing the Clubhouse building.</p> <p>Condition: The heat pumps are in operable condition with no reports of any deficiencies. It was noted that these heat pumps were replaced in 2021.</p> <p>Comments: The reserve costs include replacing all the heat pumps. It is recommended to engage a mechanical contractor to perform a condition assessment of these units before renewal.</p>

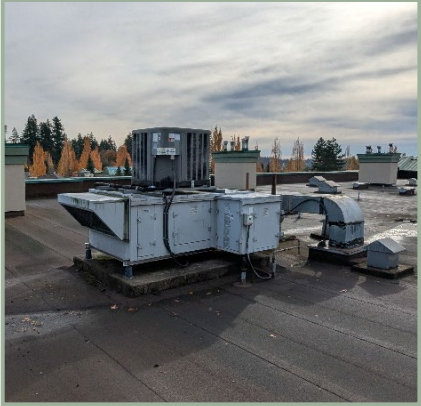
45 MAKE-UP AIR UNITS

MECHANICAL	Location:		Roofs of the condo buildings and Clubhouse building
	Year Installed:		2019
	Typical Service Life (years):		20
	Effective Age (years):		6
	Remaining Service Life (years):		14
	Planned Renewal Date:		2039
<p>Description: This item includes the make-up air units installed on the roofs of the Kensington, Mayfair and Windsor condo buildings, and the Clubhouse buildings.</p> <p>Condition: The make-up air units are in operable condition with no reports of deficiencies. It was noted that the make-up air units were fully replaced in 2019.</p> <p>Comments: The reserve costs include the replacement of the make-up air units on the roofs. It is recommended to engage a mechanical contractor to perform a condition assessment of these units before renewal.</p>

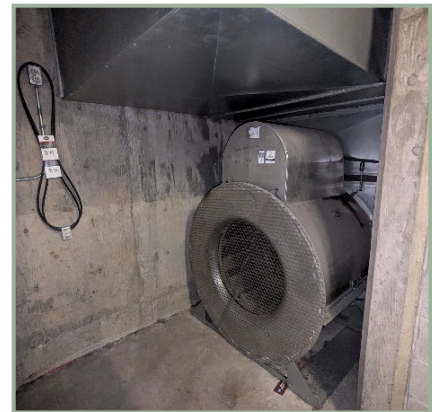
47 PARKADE EXHAUST FANS		
MECHANICAL	Location:	Throughout parkades
	Year Installed:	1995
	Typical Service Life (years):	20
	Effective Age (years):	17
	Remaining Service Life (years):	3
	Planned Renewal Date:	2028
<p>Description: This item includes the parkade exhaust fans located in the parkades.</p> <p>Condition: These exhaust fans are in operable condition.</p> <p>Comments: The reserve costs include fully replacing the exhaust fans. It should be noted that this asset is currently past its expected service life and should be inspected in the mechanical condition assessment mentioned in item #42.</p>

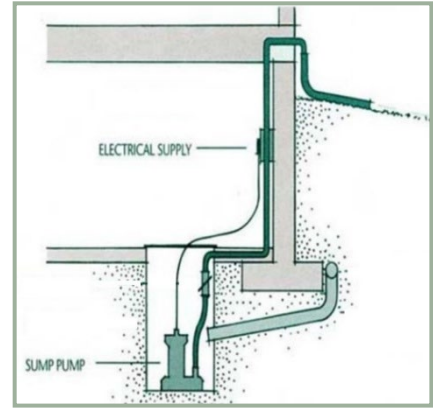
48 SUMP PUMP

Description: This item includes the sump pump underneath the Windsor building.

Condition: The sump pump could not be verified with a visual review. However, no problems or issues were reported.

Comments: The reserve costs include replacing the sump pump. It should be noted that this asset is currently past its expected service life and should be inspected in the mechanical condition assessment mentioned in item #42.

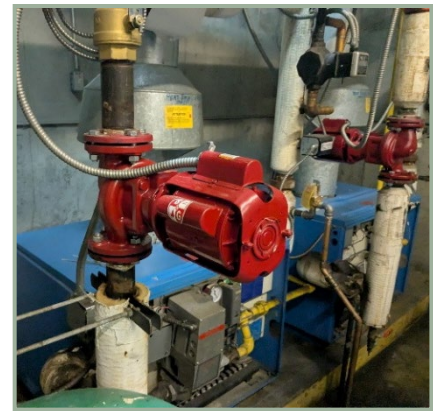
Description: This item includes the many water pumps, pressure regulating valves, backflow preventers and other miscellaneous mechanical equipment servicing the condos and Clubhouse building. This also includes the mechanical equipment servicing the pool and the hot tub in the Clubhouse building.

Condition: The miscellaneous mechanical equipment are in operable condition.

Comments: The reserve costs include an allowance for replacing and repairing some of the mechanical equipment. These equipment should be included in the mechanical condition assessment mentioned in item #42.

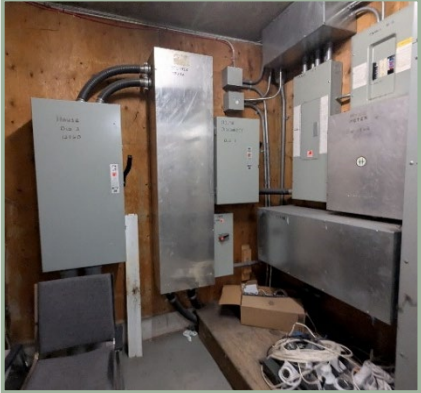
50 SERVICE DISTRIBUTION	
ELECTRICAL	Location: Electrical rooms
	Year Installed: 1995
	Typical Service Life (years): 50
	Effective Age (years): 30
	Remaining Service Life (years): 20
	Planned Renewal Date: 2045

<p>Description: This item includes the service distribution systems located in the electrical rooms throughout the property. This also includes the underground incoming service line to the property.</p> <p>Condition: This asset appears to be in fair condition with no notable deficiencies.</p> <p>Comments: Service distribution equipment often lasts beyond their expected service life with minimal maintenance, making it difficult to predict when the system might require renewal or what the risk of failure is. Often the equipment is upgraded due to increased residential demand, or replacement components become unavailable due to obsolescence. Common issues that arise from service distribution components are due to loosen connections, corrosion due to humid environment, and/or excessive dust. JRS recommends conducting periodic infrared checks for localized overheating of components to proactively identify deteriorating areas and maintain equipment performance and lifespan. Reserve costs consist of replacement for a percentage of the underground incoming service, as well as a percentage of the service distribution equipment. Extra allowance has been allotted in an interval of 10-years for infrared checks and vault maintenance.</p>

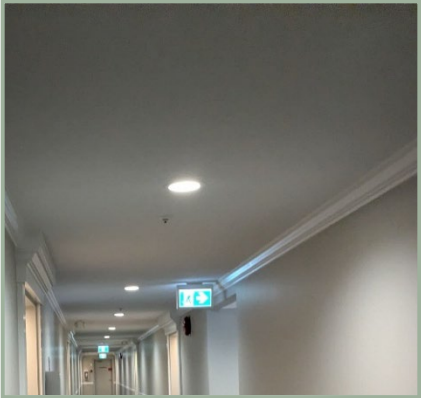
51 POWER DISTRIBUTION			
ELECTRICAL	Location:	Throughout property

Year Installed:	1995	
	Typical Service Life (years):	40	
	Effective Age (years):	30	
	Remaining Service Life (years):	10	
	Planned Renewal Date:	2035	
<p>Description: This item includes all the interior lighting in common areas for the condos and the Clubhouse building. This also includes the electrical wiring in common and shared walls with all the buildings throughout the property.</p> <p>Condition: The lighting appears to be in fair condition with no reports of any deficiencies. Wiring could not be verified with a non-exploratory review.</p> <p>Comments: Similar to service distribution equipment, the strata corporation may consider commissioning an infrared check for localized overheating of junctions and/or wiring inside walls. This cost has not been included in this report. The reserve costs include an allowance for partial renewal of the wiring and the interior lights.</p>

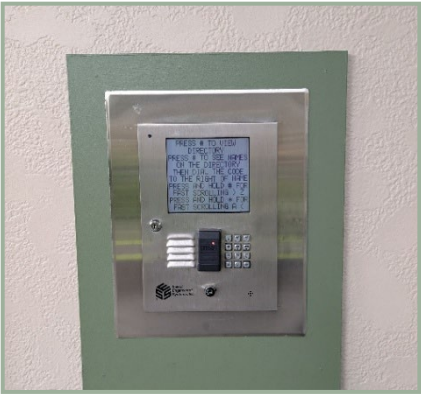
52 ENTERPHONE PANELS			
ELECTRICAL	Location:	Property and condo entrances

Year Installed:	2013	
	Typical Service Life (years):	30	
	Effective Age (years):	29	
	Remaining Service Life (years):	1	
	Planned Renewal Date:	2026	
<p>Description: This item includes the enterphone panels located at property entrances and condo building entrances. This does not include any wiring upgrade costs or system renewal.</p> <p>Condition: The enterphones are generally in operable condition. It was noted that the enterphone panel for the Windsor building was replaced in 2025, and the remainder is planned to be replaced in 2026. It was also noted that the fob system for the Windsor building is currently broken and is being planned to be renewed.</p> <p>Comments: The reserve costs include replacing the enterphone panels. JRS recommends that the strata corporation choose a replacement model that is compatible with the current building electrical systems and requires minimal wiring upgrading. An extra allowance has been allotted for the renewal of the enterphone system for the Windsor building in 2028.</p>

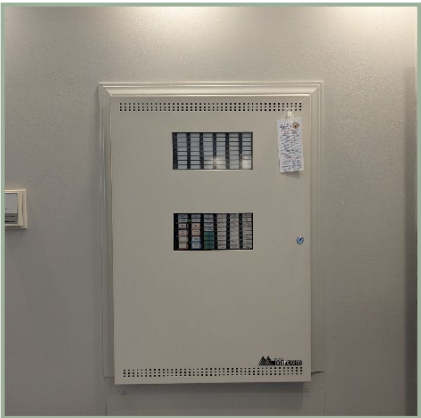
53 FIRE ALARM PANEL & EMERGENCY LIGHTING	
ELECTRICAL	Location: Condo building entrances or mechanical room
	Year Installed: 1995
	Typical Service Life (years): 20
	Effective Age (years): 19
	Remaining Service Life (years): 1
	Planned Renewal Date: 2026

<p>Description: This item includes the fire alarm panels in the lobbies of Kensington and Windsor buildings, and in the mechanical room of the Mayfair building. This also includes the emergency lighting throughout the condo buildings and their parkades.</p> <p>Condition: It was noted that the fire alarm panels for the Mayfair and Windsor buildings failed their test this year and need maintenance as soon as possible.</p> <p>Short-Term Action Required: For safety reasons, the fire alarm panels should be repaired as soon as possible to ensure they operate as intended.</p> <p>Comments: The reserve costs include replacing the fire alarm panels and a percentage of the emergency lighting. An allowance has been allotted to repair and potentially replace the fire alarm panels for the Mayfair and Windsor buildings in the following year.</p>

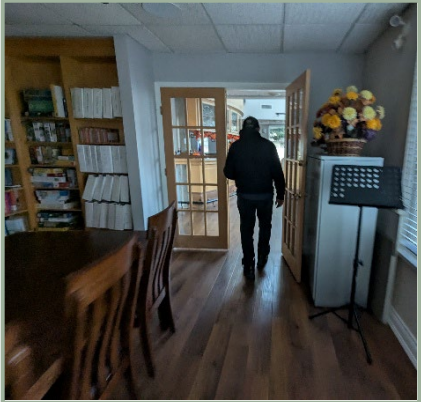
55	LIBRARY

SPECIALTY	Location:	Clubhouse building	
	Year Installed:	1995	
	Typical Service Life (years):	20	
	Effective Age (years):	10	
	Remaining Service Life (years):	10	
	Planned Renewal Date:	2035	
<p>Description: This item includes the library located inside the Clubhouse building.</p> <p>Condition: The library appears to be in fair condition.</p> <p>Comments: The reserve costs include an allowance for potential renewal expenses associated with the library.</p>

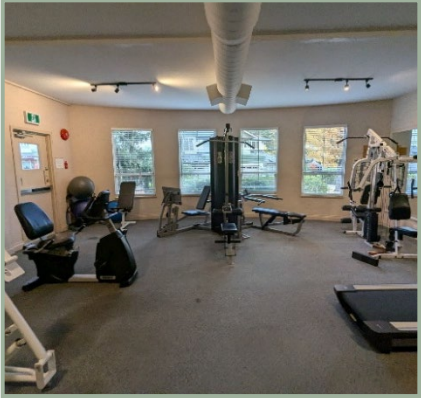
56 EXERCISE ROOM			
SPECIALTY	Location:	Clubhouse building

Year Installed:	1995	
	Typical Service Life (years):	20	
	Effective Age (years):	10	
	Remaining Service Life (years):	10	
	Planned Renewal Date:	2035	
<p>Description: This item includes the exercise room located in the Clubhouse building.</p> <p>Condition: The exercise room and its equipment are in operable condition with no reports of any issues.</p> <p>Comments: The reserve costs include an allowance for potentially replacing some of the exercise equipment.</p>

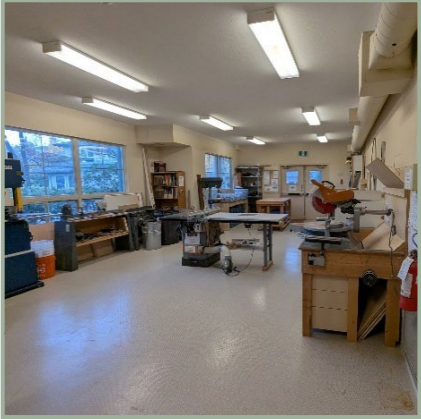
57 WORKSHOP			
SPECIALTY	Location:	Clubhouse building

Year Installed:	1995	
	Typical Service Life (years):	20	
	Effective Age (years):	10	
	Remaining Service Life (years):	10	
	Planned Renewal Date:	2035	
<p>Description: This item includes the workshop located in the Clubhouse building.</p> <p>Condition: The workshop appears to be in operable condition with no reports of any issues.</p> <p>Comments: The reserve costs include an allowance for potentially replacing some of the equipment in the workshop.</p>

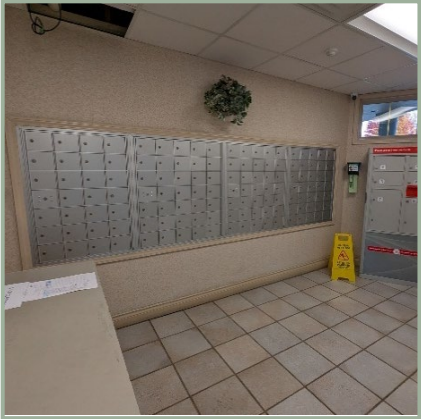
58 MAILROOM			
SPECIALTY	Location:	Clubhouse building

Year Installed:	1995	
	Typical Service Life (years):	30	
	Effective Age (years):	20	
	Remaining Service Life (years):	10	
	Planned Renewal Date:	2035	
<p>Description: This item includes the Mailroom located in the Clubhouse building.</p> <p>Condition: The mailroom is in operable condition with no reports of any deficiencies</p> <p>Comments: The reserve costs include an allowance for replacing the mailbox panels.</p>

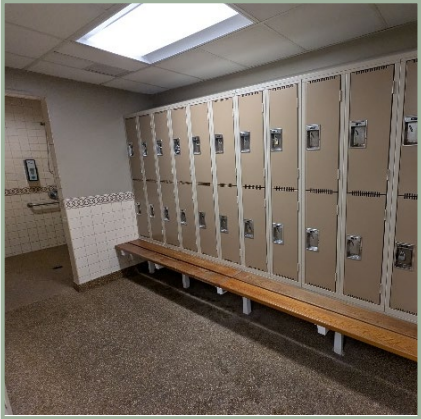
59 CHANGE/SHOWER ROOMS			
SPECIALTY	Location:	Clubhouse building

Year Installed:	1995	
	Typical Service Life (years):	20	
	Effective Age (years):	10	
	Remaining Service Life (years):	10	
	Planned Renewal Date:	2035	
<p>Description: This item includes the two shower/change/bathrooms located in the Clubhouse building, right next to the hot tub entrance.</p> <p>Condition: This asset is in operable condition with no reports or observations of any deficiencies.</p> <p>Comments: The reserve costs include an allowance for renewing some of the showers and bathroom components.</p>

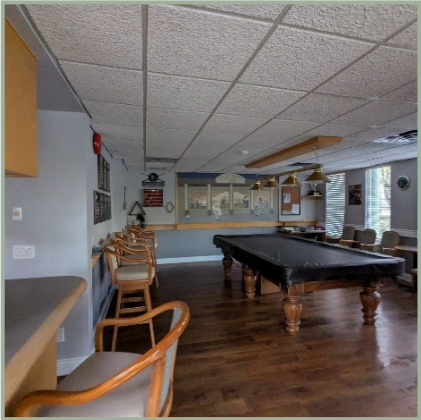
60 LOUNGES & BILLIARDS ROOM			
SPECIALTY	Location:	Clubhouse building

Year Installed:	1995	
	Typical Service Life (years):	30	
	Effective Age (years):	20	
	Remaining Service Life (years):	10	
	Planned Renewal Date:	2035	
<p>Description: This item includes the lounge spaces as well as the billiards room beside the bar located in the Clubhouse building.</p> <p>Condition: These spaces are in fair condition with no observations or reports of any deficiencies.</p> <p>Comments: The reserve costs include an allowance for potential renewal expenses associated with the lounge and the billiards room.</p>

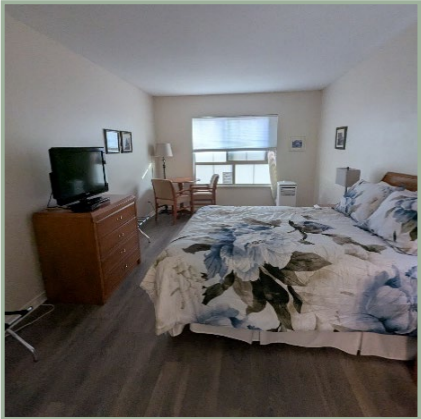
61 GUEST SUITES			
SPECIALTY	Location:	Clubhouse building

Year Installed:	1995	
	Typical Service Life (years):	30	
	Effective Age (years):	15	
	Remaining Service Life (years):	15	
	Planned Renewal Date:	2040	
<p>Description: This item includes the three guest suites located on the second floor of the Clubhouse building.</p> <p>Condition: The guest suites are in reasonable condition. Per the client review, it was noted that the strata council refurbished some of the guest suites in 2026, therefore the renewal date has been pushed back to 2040.</p> <p>Comments: The reserve costs include an allowance for renewing some of the interior finish and furnishings inside these guest suites.</p>

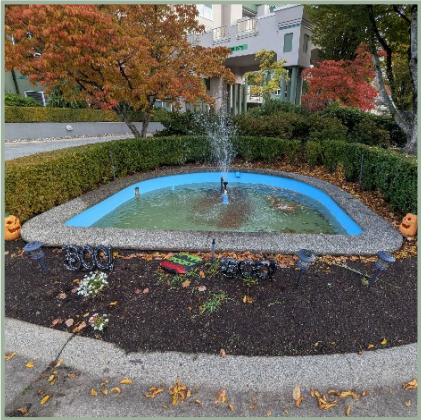
62 FOUNTAIN			
SPECIALTY	Location:	Throughout property

Year Installed:	1995	
	Typical Service Life (years):	20	
	Effective Age (years):	10	
	Remaining Service Life (years):	10	
	Planned Renewal Date:	2035	
	<p>Description: This item includes all the fountains that are placed throughout the property.</p> <p>Condition: The fountains were in operable condition. It was observed that one of the fountains in front of the Kensington building was under maintenance on the day of the site visit.</p> <p>Comments: The reserve costs include an allowance for membrane renewals and potential pump replacements for the fountains.</p>

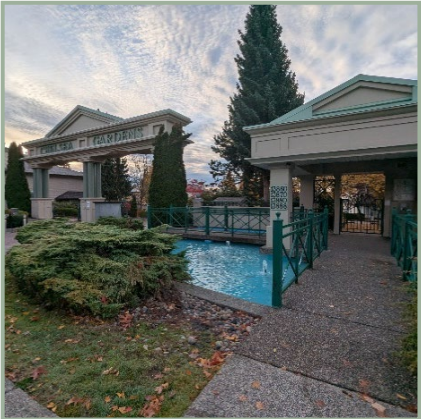
63 OUTBUILDING STRUCTURES			
SPECIALTY	Location:	Throughout property

Year Installed:	2025	
	Typical Service Life (years):	25	
	Effective Age (years):	0	
	Remaining Service Life (years):	25	
	Planned Renewal Date:	2050	
	<p>Description: This item includes the front entrance, kiosks and the Chelsea Garden corner sign structures found throughout the property.</p> <p>Condition: It was reported by the strata manager that these structures were fully refurbished in 2025.</p> <p>Comments: The refurbishment cost has been deducted in the projections for the year 2025. The reserve costs include an allowance for targeted repair work and partial rehabilitation.</p>

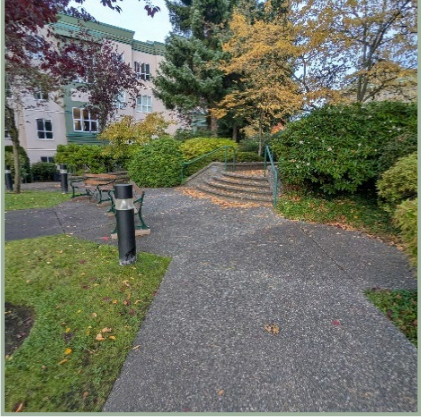
64	SOFTSCAPING		
SITE SERVICES	Location:	Throughout property

Year Installed:	1995	
	Typical Service Life (years):	50	
	Effective Age (years):	30	
	Remaining Service Life (years):	20	
	Planned Renewal Date:	2045	
	Description: This item includes the removal and reinstatement of plants, trees and greenery found throughout the property.		
Condition: The softscaping is generally in good condition. However, it was reported that some of the trees in front of the townhouses were disrupting the perimeter drain system around the property.			
Comments: The reserve costs include renewing a percentage of the total softscaping found in the property. An allowance has been made in 2030 for potential tree removals and reinstatement of greenery due to the problem mentioned above. Extra allowances have been allocated over an interval of every 10 years for maintenance and targeted renewals.

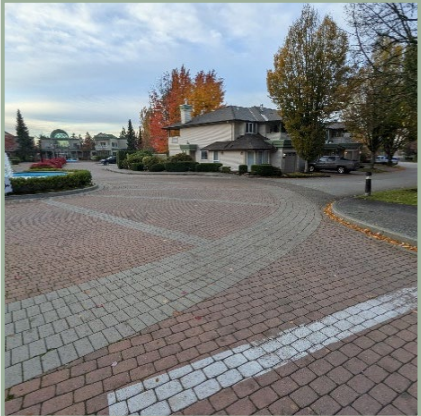
65	HARDSCAPING		
SITE SERVICES	Location:	Throughout property

Year Installed:	1995	
	Typical Service Life (years):	50	
	Effective Age (years):	30	
	Remaining Service Life (years):	20	
	Planned Renewal Date:	2045	
	Description: This item includes the paved roads, sidewalks and concrete/brick pavers throughout the property.		
Condition: The hardscaping around the property is in reasonable condition. Minor cracks were observed on the roadway leading to the parkade entrance of the Mayfair and Kensington condo buildings.			
Comments: The reserve costs include an allowance for targeted repairs and renewals of the hardscaping found in the property. Similar to softscaping (item #64), allowances have been made in 2030 for targeted repair work that may follow after the tree removals, and for maintenance in an interval of 10 years.

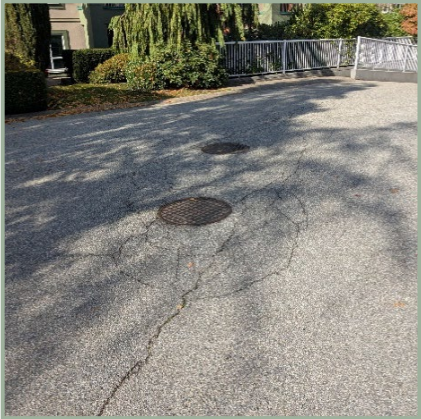
66 UNDERGROUND WATER SUPPLY & DRAINAGE			
SITE SERVICES	Location:	Throughout property

Year Installed:	1995	
	Typical Service Life (years):	50	
	Effective Age (years):	30	
	Remaining Service Life (years):	20	
	Planned Renewal Date:	2045	
<p>Description: This item includes the water, sanitary and storm lines that run through the underground of the property. This also includes the perimeter drains around the buildings.</p> <p>Condition: The underground lines could not be verified without a more comprehensive review of the system. As mentioned before in item #64, it was reported that tree roots were disrupting the drainage system around some townhouses. Additionally, the strata manager noted that the drainage around the Windsor condo building was upgraded in 2021.</p> <p>Comments: The reserve costs include an allowance for targeted repairs of the water, sanitary storm and drainage lines throughout the property. An allowance has been made in 2030 for targeted repair work of the disturbed drainage system on some townhouses.</p>

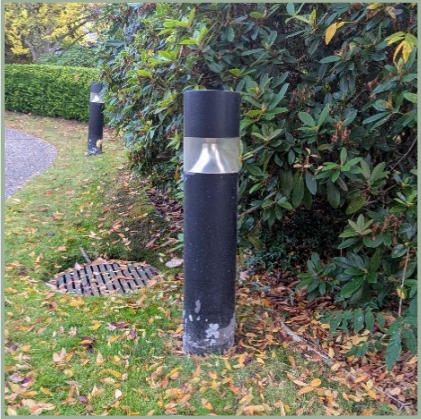
67 OUTDOOR LIGHTING & ELECTRICAL			
SITE SERVICES	Location:	Throughout property

Year Installed:	1995	
	Typical Service Life (years):	40	
	Effective Age (years):	30	
	Remaining Service Life (years):	10	
	Planned Renewal Date:	2035	
<p>Description: This item includes all the exterior lighting found throughout the property. This includes the exterior lights attached to the townhouses and the light posts around walkways.</p> <p>Condition: The operability of the exterior lighting could not be observed due to the time of the site visit; however, no issues were reported.</p> <p>Comments: The reserve costs include an allowance for replacing some of the exterior lighting throughout the property.</p>
