# **DEPRECIATION REPORT CHELSEA GARDENS (2021 UPDATE)**

13860 – 13888 70<sup>th</sup> Avenue  
Surrey, British Columbia

Report No. 1433.DR00

July 6, 2021

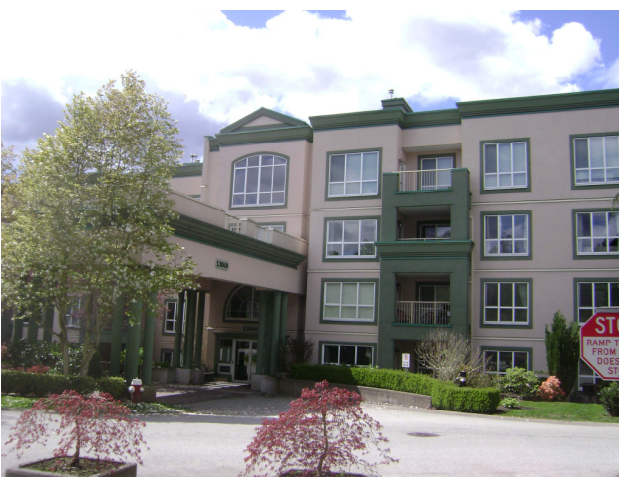
**Photo #1**

The Kensington – 13860-70<sup>th</sup> Avenue

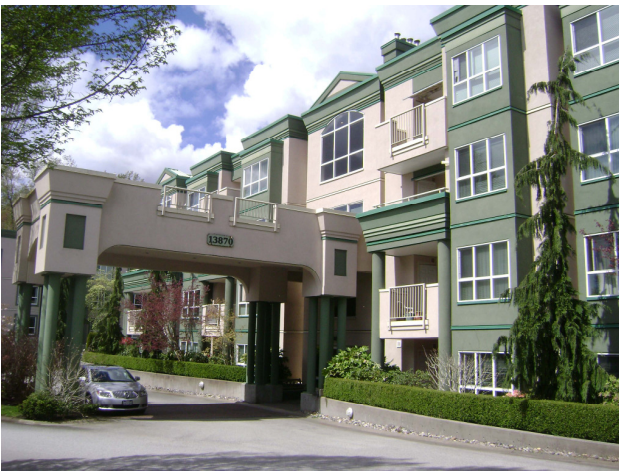
**Photo #2**

The Mayfair – 13870-70<sup>th</sup> Avenue

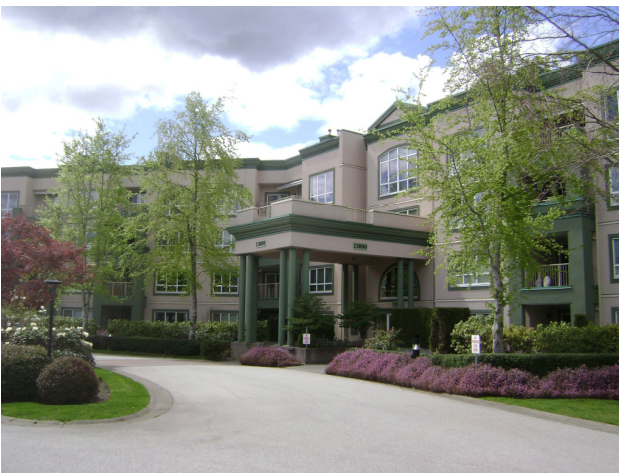
**Photo #3**

The Windsor – 13880-70<sup>th</sup> Avenue

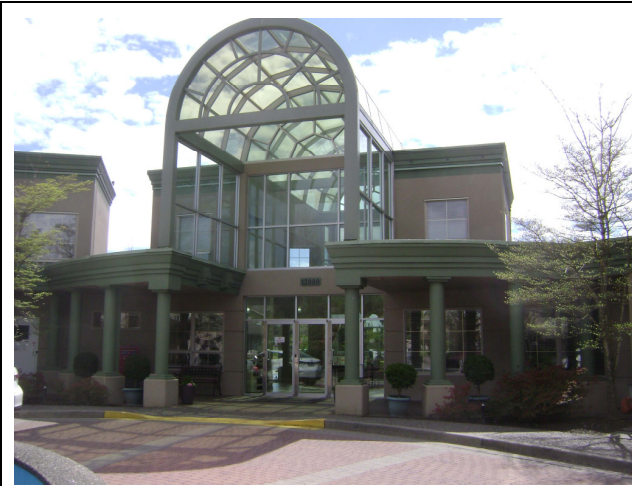
**Photo #4**

The Clubhouse – 13888-70<sup>th</sup> Avenue

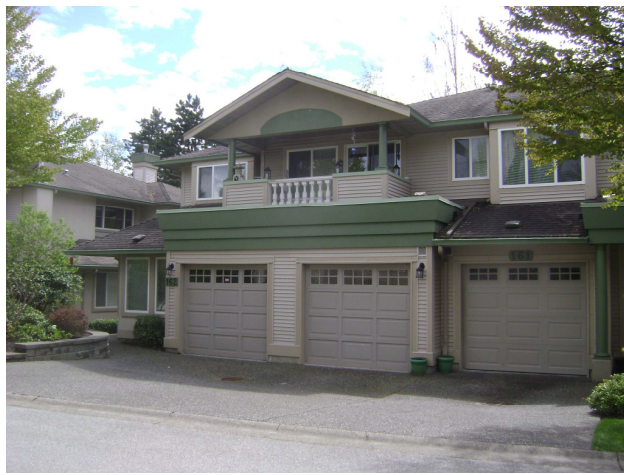
**Photo #5**

Townhouses (#101-#334)

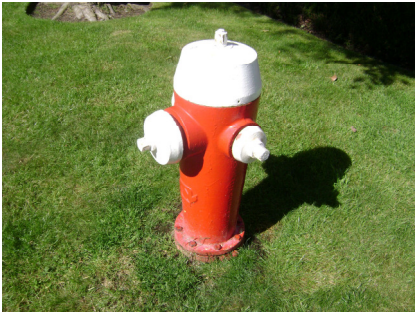
<b>Item:</b>	<b>Fire 6</b>
	<b>Description:</b>	Fire Hydrants
	<b>Location:</b>	Various locations around complex (at Buildings '60, '80, '88, at TH#329, by north entrance & by east entrance)
	<b>Current Age:</b>	N/A
	<b>Service Life:</b>	N/A
<b>Assessment:</b>	There are at least 6 fire hydrants at the complex. Inspection of the fire hydrants are typically conducted on an annual basis, the last time being April 2021. There were no reported problems.	
<b>Recommendation:</b>	Testing/inspection of the fire hydrant should continue on an annual basis with repairs/replacement as required (operating budget). No allowance has been made in the table. All shrubs and other landscaping around fire hydrants should be kept back so that the hydrant is visible at all times.

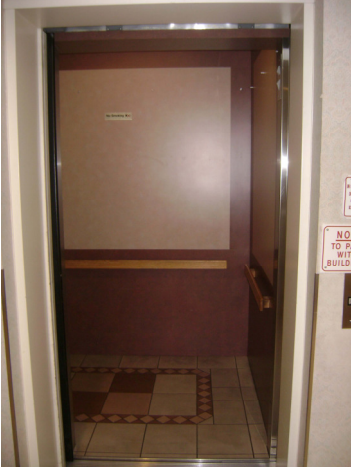
<b>Item:</b>	<b>Elev 1</b>
	<b>Description:</b>	Hydraulic Passenger Elevator (Richmond Elevator)
	<b>Location:</b>	Buildings '60, '70 & '80
	<b>Current Age:</b>	26 years (1995)
	<b>Service Life:</b>	30 years
<b>Assessment:</b>	<p>There is one elevator at The Kensington, The Mayfair &amp; The Windsor (3 in total). The elevator machine room is located in the underground parkade. Records indicate that the elevator is currently being serviced on a monthly basis by Richmond Elevator Maintenance Ltd. All service records are up to date and current.</p> <p>According to the service contractor/manufacturer and Strata, no major upgrades to the elevator systems have been completed. Some cosmetic upgrades to the interior cab were noted.</p>	
<b>Recommendation:</b>	<p>The elevator system is of all original equipment (approx. 26 years old). Major/heavy duty components of the elevator tend to wear out over time, therefore, service to these components is critical and usually required every 25-30 years. This includes inspection and full system upgrade/modernization/replacement of the existing control systems, door system, wiring, fixtures, electrical buttons, etc, and any code related items. A cost for this work has been included for in the table (spread over three years). There may be some flexibility with the costs and timelines of some of the major items. MVL recommends that the recommendations of the elevator manufacturer be followed to ensure a high level of service operation and to meet current code requirements. In the mean time, regular servicing of the elevator should be an ongoing maintenance item, as part of the service contract (operating budget).</p> <p>Replacement of the hydraulic cylinder has also not been completed and should be reviewed and most likely replaced at the same time as modernization. We have included a future cost to replace this item for each elevator.</p>

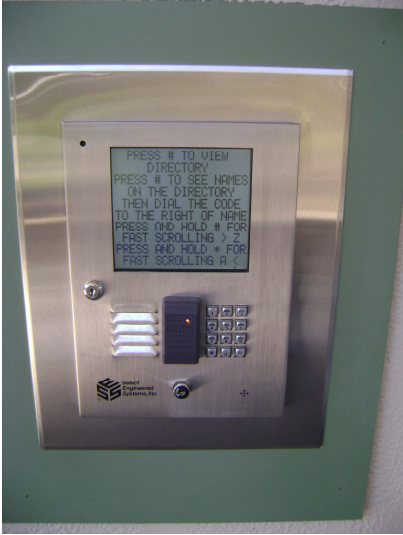
<p><b>Item:</b></p>	<p><b>Sec 1</b></p>
	<p><b>Description:</b></p>	<p>Security System (Enterphone &amp; FOB)</p>
	<p><b>Location:</b></p>	<p>Buildings '60,'70,'80,'88 (front entry and parkade gates), entry gates at complex (2 entrances)</p>
	<p><b>Current Age:</b></p>	<p>Enterphone – 8 years (2013) FOB System – 4 years (2017)</p>
	<p><b>Service Life:</b></p>	<p>Enterphone - 15 years FOB System – 15 years</p>
<p><b>Assessment:</b></p>	<p>The building security system consists of front panel enterphones and a FOB system for common areas gates and doors. The building security system is currently being serviced on an as-needed basis.</p> <p>According to the Strata, the enterphones were replaced in 2013 and have been operating as intended with minimal maintenance. No current problems were reported with the telephone entry system. The existing FOB system was upgraded in 2017.</p>	
<p><b>Recommendation:</b></p>	<p>These systems are relatively maintenance free, with servicing only required if problems occur. Future replacement of the panels and FOB system has been included for in the table, based on expected service life.</p> <p>The entire security system should be checked after any future repairs are completed to ensure a full functioning and integrated security system.</p>

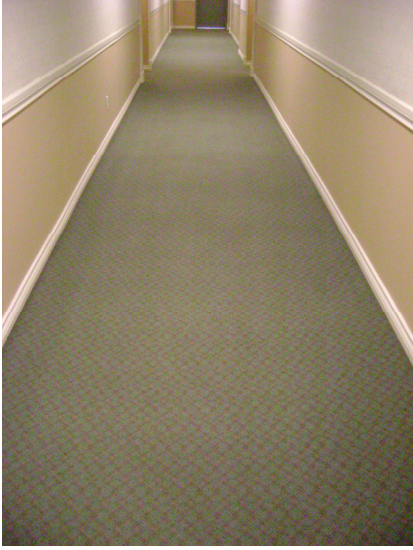
<b>Item:</b>	<b>Floor 1</b>
	<b>Description:</b>	Carpet
	<b>Location:</b>	Buildings '60,'70,'80,'88 – interior hallways, common rooms, mezzanine, guest rooms, manager suite, exercise room and stairwells
	<b>Current Age:</b>	Buildings '80 – 0 years (2021) Building '60 – 0 years (2021) Building '70 – 2 years (2019) Building '88 – 6 years (2015) & 8 years (2013)
	<b>Service Life:</b>	20 years
<b>Assessment:</b>	The carpet in the common areas varies in age.	
<b>Recommendation:</b>	Future replacement of the carpeting has been included for in the table, based on expected service life and current conditions.

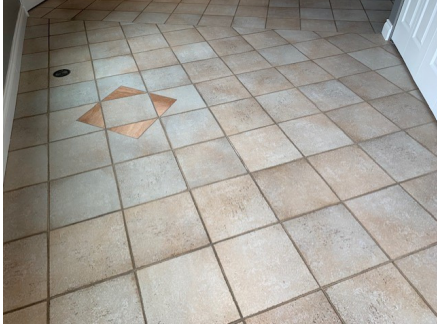
<b>Item:</b>	<b>Floor 2</b>
	<b>Description:</b>	Tile
	<b>Location:</b>	Building '88 – lobby, hallways, mail room, kitchen, bathrooms
	<b>Current Age:</b>	26 years
	<b>Service Life:</b>	40 years
<b>Assessment:</b>	The observed tile appeared to be in satisfactory condition with no major deficiencies observed or reported.	
<b>Recommendation:</b>	Minor repairs and routine maintenance should be completed, as required, as part of the operating budget. This may include re-grouting of the tile or replacing cracked tiles (operating budget). Future replacement costs have been included in the table, based on expected service life.

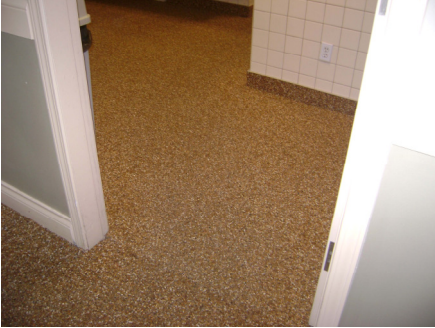
<b>Item:</b>	<b>Floor 4</b>
	<b>Description:</b>	Epoxy
	<b>Location:</b>	Building '88 – spa room, change rooms
	<b>Current Age:</b>	5 years (2016)
	<b>Service Life:</b>	25 years
<b>Assessment:</b>	The observed epoxy flooring was installed in 2016 and appeared to be in satisfactory condition with no major deficiencies observed or reported.	
<b>Recommendation:</b>	Minor repairs and routine maintenance should be completed, as required, as part of the operating budget. Re-finishing/re-sealing of the surface may be required from time to time to maintain the original look. Future replacement cost has been included in the

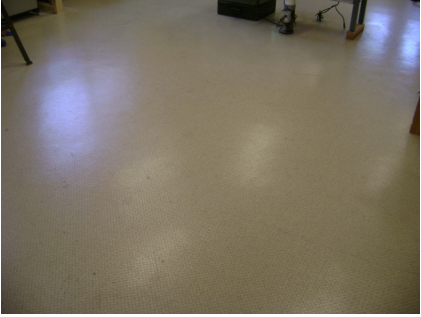
<b>Item:</b>	<b>Floor 5</b>
	<b>Description:</b>	Vinyl
	<b>Location:</b>	Building '88 - workshop
	<b>Current Age:</b>	26 years
	<b>Service Life:</b>	35 years
<b>Assessment:</b>	The vinyl flooring was in satisfactory condition for its age with no major deficiencies noted or reported, other than normal wear and tear over time. This area gets limited use.	
<b>Recommendation:</b>	Future replacement of the vinyl has been included for in the table, based on expected service life.

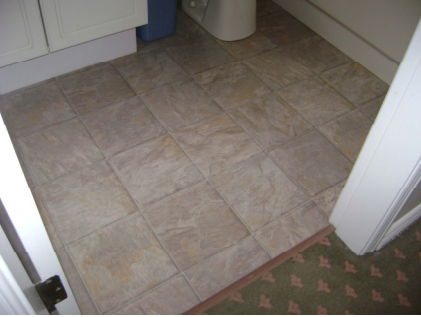
<b>Item:</b>	<b>Floor 6</b>
	<b>Description:</b>	Linoleum
	<b>Location:</b>	Building '88 – manager's Suite (kitchen,bath), guest rooms (bath)
	<b>Current Age:</b>	26 years
	<b>Service Life:</b>	35 years
<b>Assessment:</b>	The linoleum was in satisfactory condition for its age with no major deficiencies noted or reported, other than normal wear and tear over time.	
<b>Recommendation:</b>	Future replacement of the linoleum has been included for in the table, based on expected service life.

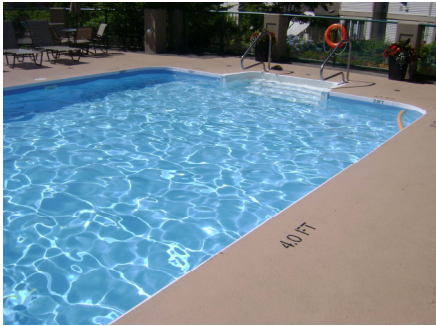
<b>Item:</b>	<b>Rec 1</b>
	<b>Description:</b>	Outdoor Pool
	<b>Location:</b>	Building '88
	<b>Current Age:</b>	5 year (2016) - liner
	<b>Service Life:</b>	6 years
<b>Assessment:</b>	The interior of the swimming pool is protected with a vinyl liner, which was replaced in 2016. Some patch repairs to the liner have been completed over the years.	
<b>Recommendation:</b>	The protective liner should be monitored. Future replacement cost has been included in the table.

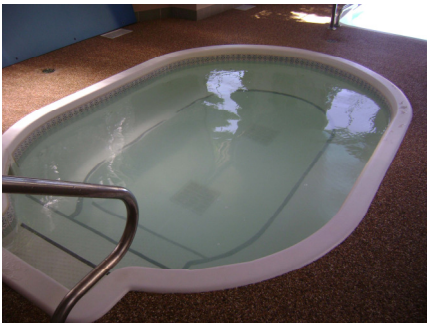
<b>Item:</b>	<b>Rec 2</b>
	<b>Description:</b>	Hot Tub
	<b>Location:</b>	Building '88
	<b>Current Age:</b>	26 years
	<b>Service Life:</b>	35 years
<b>Assessment:</b>	The hot tub is a one piece, all inclusive unit. No problems were noted or reported.	
<b>Recommendation:</b>	The interior of the hot tub should be cleaned and maintained as required. Future replacement cost has been included in the table.

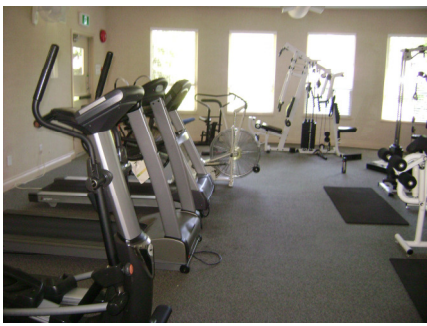
<b>Item:</b>	<b>Rec 3</b>
	<b>Description:</b>	Gym Equipment
	<b>Location:</b>	Building '88 - Exercise Room
	<b>Current Age:</b>	Varies
	<b>Service Life:</b>	Varies

<b>Assessment:</b>	Various gym equipment is available in the exercise room, for use by the residents of Chelsea Gardens. No current problems were reported.
<b>Recommendation:</b>	Repairs/replacement/maintenance to the gym equipment is on an as-needed basis. We have included an ongoing cost allowance in the table to repair/replace the gym equipment, as needed.

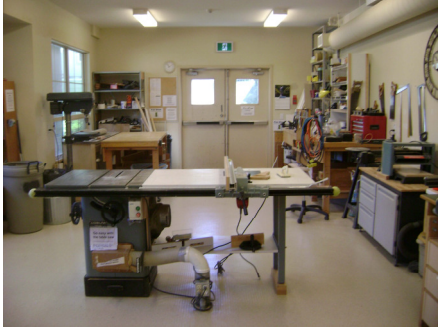
<b>Item:</b>	<b>Rec 4</b>
	<b>Description:</b>	Workshop
	<b>Location:</b>	Building '88 – Workshop Room
	<b>Current Age:</b>	Varies
	<b>Service Life:</b>	Varies
<b>Assessment:</b>	Various tools and machinery is available in the workshop, for use by the residents of Chelsea Gardens. No current problems were reported.	
<b>Recommendation:</b>	Repairs/replacement/maintenance to the tools and machinery is on an as-needed basis. We have included a small ongoing cost allowance in the table to repair/replace items, as needed.

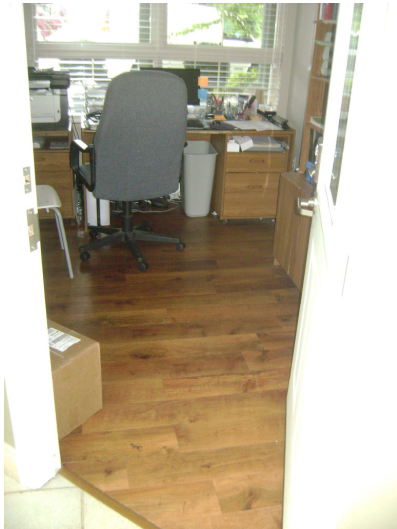
<b>Item:</b>	<b>Comm 1</b>
	<b>Description:</b>	Office
	<b>Location:</b>	Building '88
	<b>Current Age:</b>	Varies (2019-2020)
	<b>Service Life:</b>	Varies
<b>Assessment:</b>	The main office for the complex is located in the Clubhouse and contains furniture (desk, chair, shelves) and computer equipment. Upgrades have been made over the years. No problems were reported.	
<b>Recommendation:</b>	The above mentioned items should be maintained/repaired/replaced, as needed, as part of the operating budget. No allowance has been made in the table.

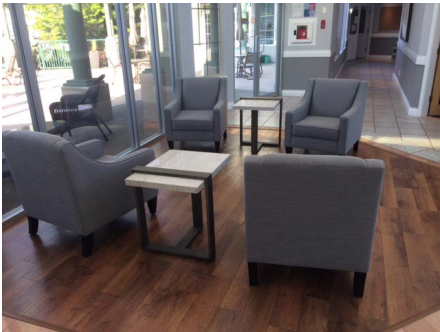
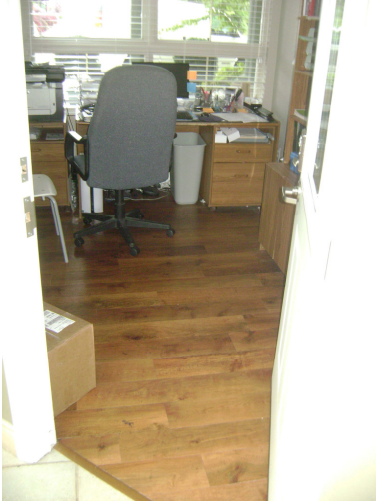
<b>Item:</b>	<b>Comm 2</b>
	<b>Description:</b>	Lobby, Billiard Lounge, Fireside Lounge, Library, Mezzanine, Guest Rooms, Manager Suite, Pool Deck
	<b>Location:</b>	Buildings '60, '70, '80 & '88
	<b>Current Age:</b>	Varies (2018-2021)
	<b>Service Life:</b>	Varies

<p><b>Assessment:</b></p>	<p>The above mentioned common rooms (mainly located in The Clubhouse) are available for ongoing use by the residents of the complex. These rooms contain items such as furniture (tables, chairs, sofas, beds, desks), electronics, games tables, library, piano &amp; barbeque. No problems were reported.</p>	
<p><b>Recommendation:</b></p>	<p>All items outlined above should be maintained/repaired/replaced, as needed. We have included an ongoing cost allowance in the table to repair/replace the various items as required.</p>

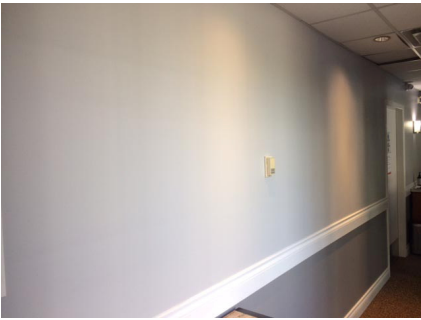
<p><b>Item:</b></p>	<p><b>Comm 3</b></p>
	<p><b>Description:</b></p>	<p>Paint (interior)</p>
	<p><b>Location:</b></p>	<p>Buildings '60, '70, '80 &amp; '88 (hallways, lobby, common rooms)</p>
	<p><b>Current Age:</b></p>	<p>Building '60 – 0 years (2021) Building '70 – 3 years (2018) Building '80 – 0 years (2021) Building '88 – 0 years (2021)</p>
	<p><b>Service Life:</b></p>	<p>20 years</p>
<p><b>Assessment:</b></p>	<p>The interior (common areas) of the apartment buildings and Clubhouse have been painted at various times throughout the years. No problems were reported or observed.</p>	
<p><b>Recommendation:</b></p>	<p>Future cost of interior painting has been included for in the table, based on expected service life.</p>
